Appendix C: Spring Inventory and Assessment Reports for Springs Surveyed for Fire Effects

Springs outside of the Upper Santa Cruz River Basin used in Fire Effects and Fuels Analysis

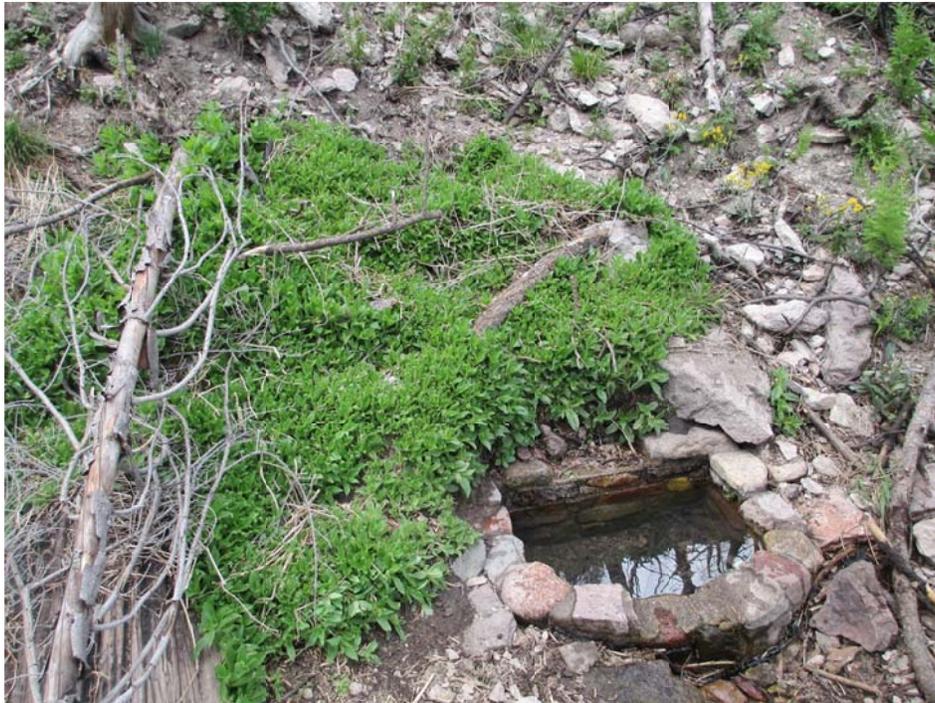
Fig 1 Anita Spring.

Survey Notes: The area has burned recently. The site is surrounded by erosion gullies and standing dead burned trees.

Management Recommendations: This spring is in the Chiricahua Wilderness on a side trail to the main Chiricahua Ridge trail. It is used by hikers/backpackers as well as local bears as a water source. The site has suffered some erosion, especially in the runout channel due to fire in the surrounding hillslopes and unstable soil. The trail leading to the site is in poor shape and suffering from erosion and user created spurs. Overall the site could benefit from some erosion stabilization and possibly restoration of the diversity of plants expected to be at this type of site (assuming some plant diversity has been lost due to fire and seed bank loss.)

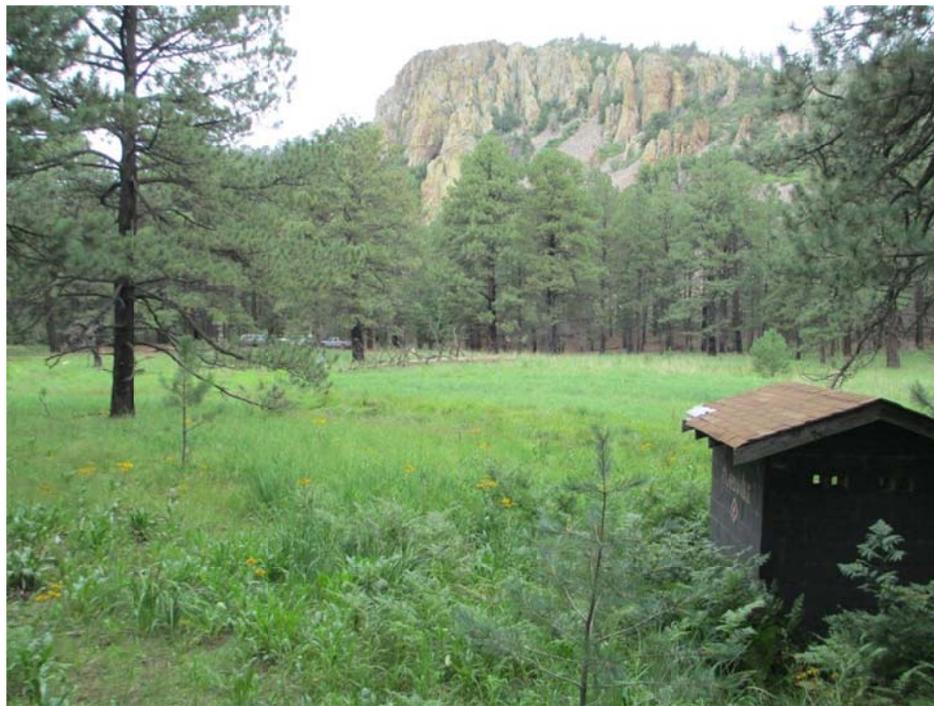
Fig 3 Barfoot Spring: View of flammable material storage facility above spring box.

Management Recommendations: Some of the fencing around the site is in disrepair. It's highly recommended that the perimeter fence be adequately maintained to preclude access to cows. The site has been modified via digging pools to allow bats access to water. We recommend that this practice be discontinued unless the wet meadow habitat can be left undisturbed.

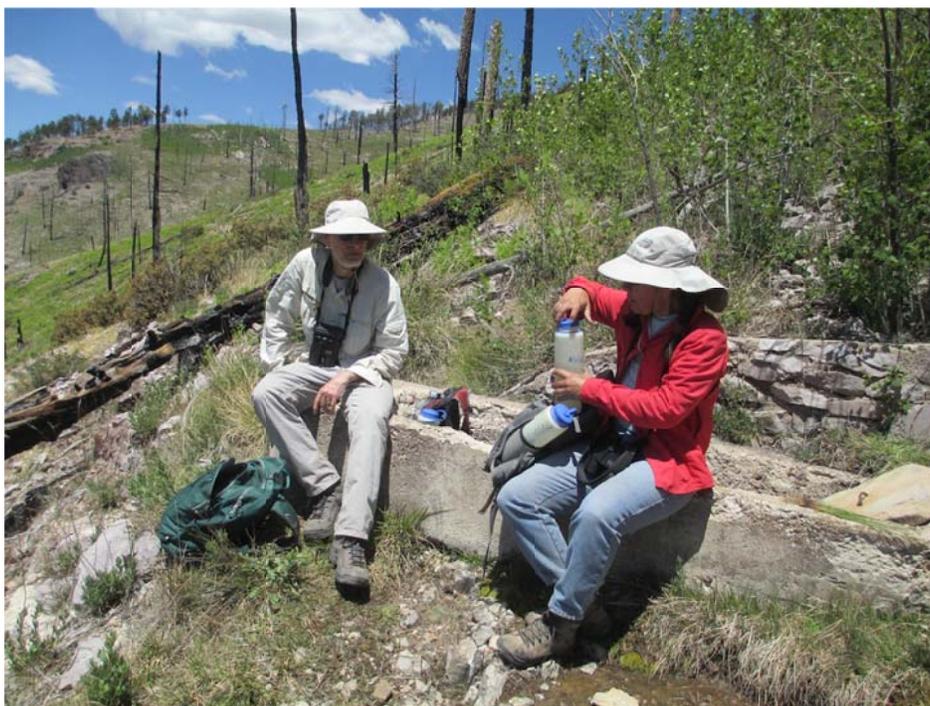
Fig 1 Deer Spring: best available image of spring

Survey Notes: The site is on a severely burned steep slope. It is barely flowing. There is some aspen regeneration happening right above the spring.

Management Recommendations: Site is on very steep slopes in an area that burned severely. It is being effected by erosion, is developed for human use and continues to be used by backpackers in the wilderness. Site is suffering erosion due to the surrounding land condition and is believed to be significantly dewatered due to the loss of canopy cover and other alterations post fire. The site could benefit from upslope erosion control, a trail to send backpackers to the box in the least erosive way, and possibly from restoration of the diversity of plant species you might expect at this type of site. It has lost much of its function as a microhabitat

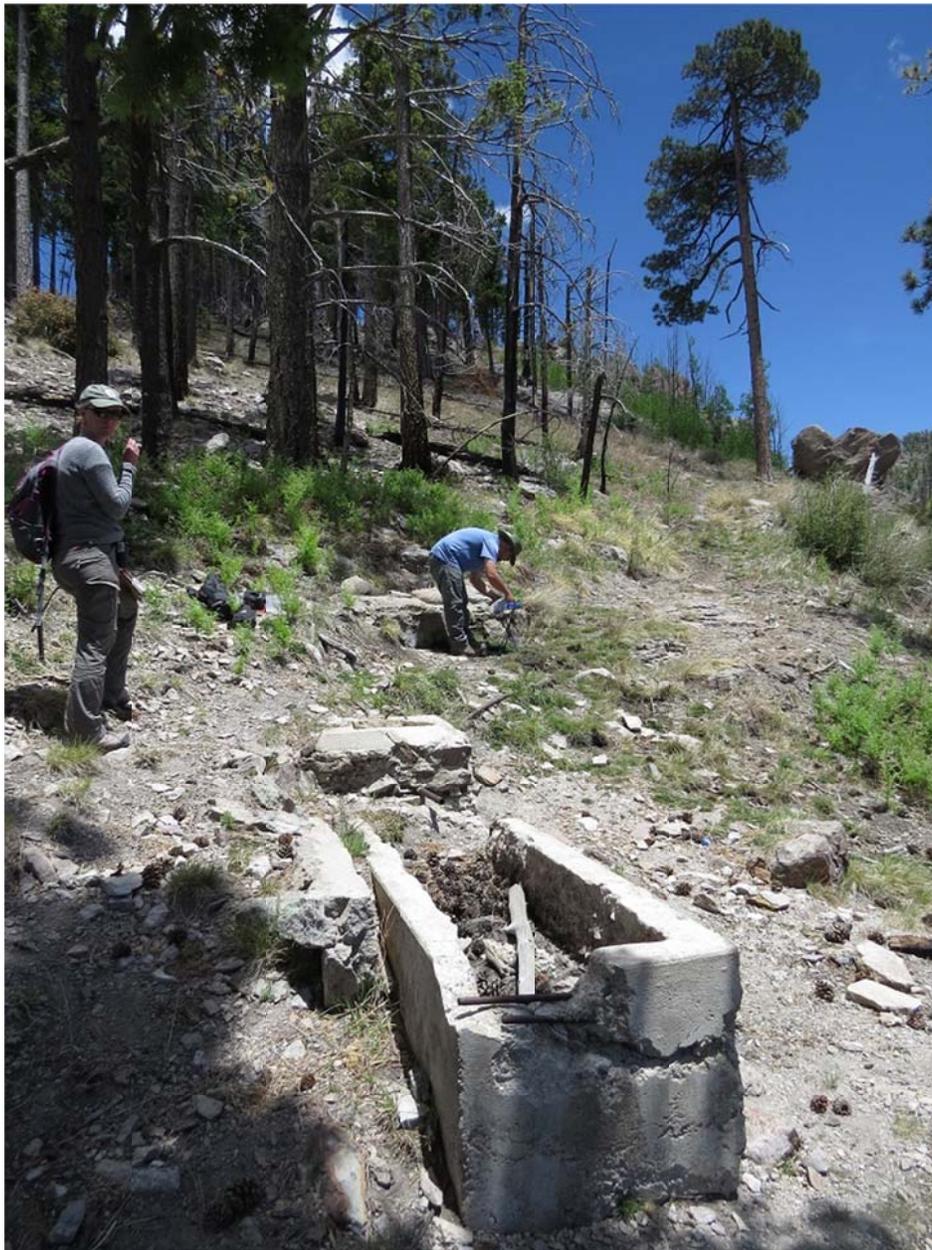
Fig 1 Juniper Spring.

Survey Notes: The site is on the edge of a burn area. The southern-most spring box is dry and disconnected (pipe broken).

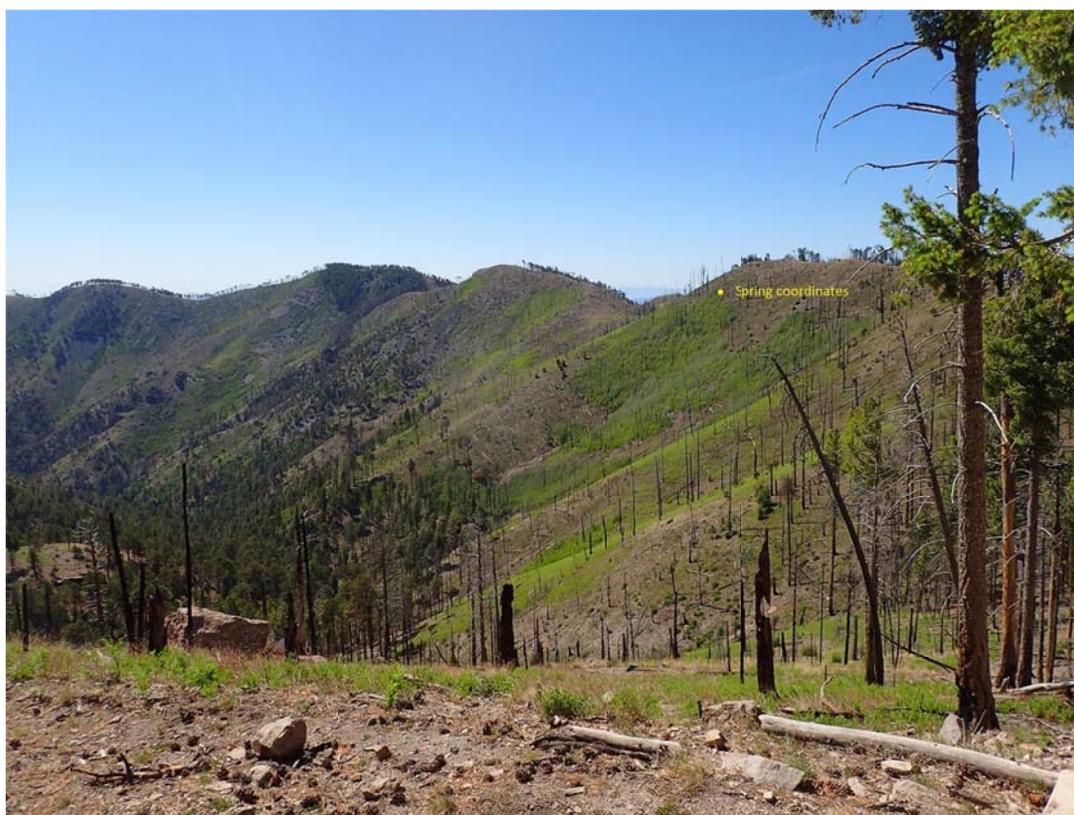
Fig 1 Lone Juniper Spring. Spring coordinates fall on distant slope at top of aspens

Survey Notes: The surveyors spent searched the hillside in the vicinity of the coordinates thoroughly and found no spring. The area was burned quite badly in 2011. However, there is a dense stand of aspen regenerating at the site, and the center top of the stand begins exactly at the coordinates, where the soil is also slightly damp - it is possible there was once an emergent spring here, and there is still a hypocrene spring at this location. Zac Ribbing (USFS) has also searched for this spring and found nothing.

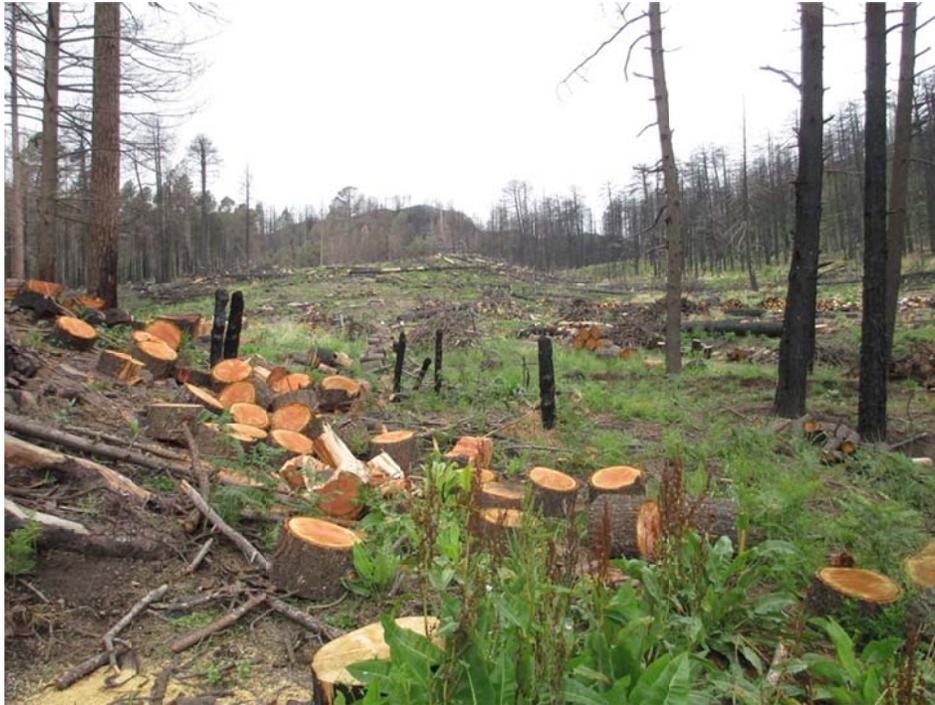
Fig 3 Lower Rustler Spring: At spring origin, looking upstream at fire damage

Management Recommendations: The spring is in an area that burned severely. The USFS is actively cutting down burned trees all around the site. At the time of the visit, burned trees were actually down and being cut across the spring run. Also within a popular developed campground near the road in. The springs is the source of a stream that continues down the mountain. Although the forest is burned all around the spring emmersion, there are areas upslope that have not burned.

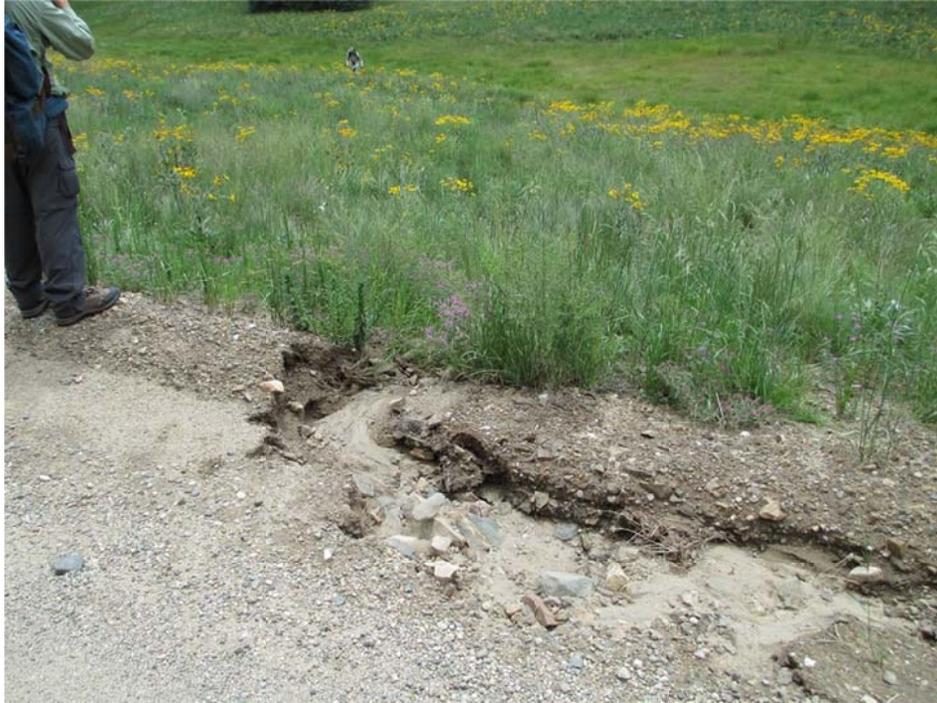
Fig 3 Western Hospital Flat Unnamed: erosion from road going into meadow
