Appendix B: Spring Inventory and Assessment Reports for Springs Surveyed in the Upper Santa Cruz Basin Study Area

Springs surveyed in the Upper Santa Cruz River Basin

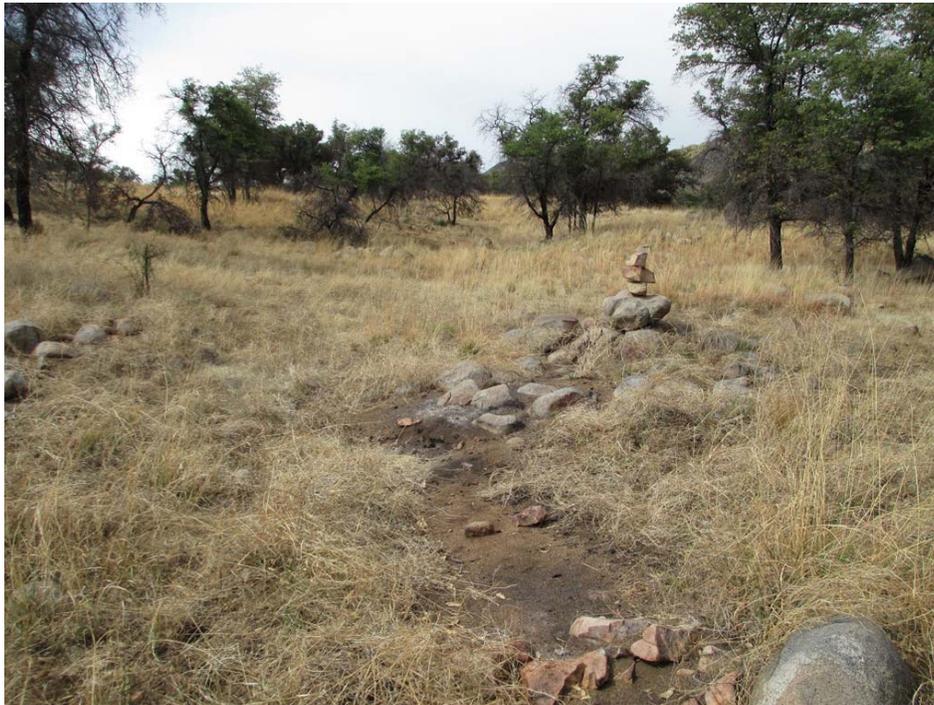
Fig 1 Basin Spring: possible previous location of spring

Survey Notes: Spring not found. There was no sign of spring vegetation or habitat found. There was a small depression that may have previously been a hillslope spring site.

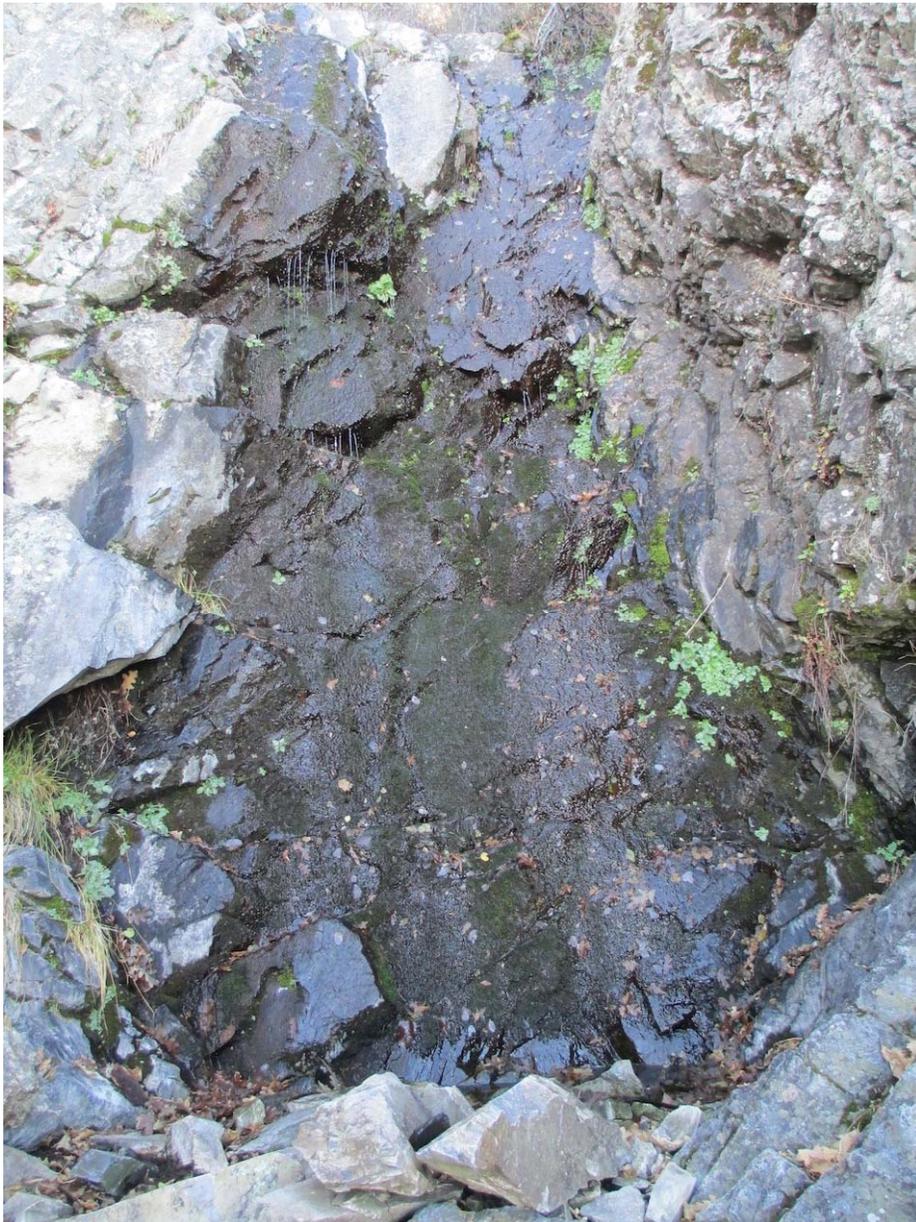
Fig 1 Bellows Spring.

Survey Notes: This spring is in an area that burned severely several years ago, which may have influenced the spring. There is a recreational trail created by hikers experiencing some erosion to the side of the channel. Overall, the spring is in good shape and providing water for wildlife.

Management Recommendations: This spring is in an area that burned severely years ago which may have influenced spring flow amount. There is a recreational trail created by hikers experiencing some erosion to the side of the channel. Overall this spring is in good shape and can continue to be managed as is. Is providing water for wildlife.

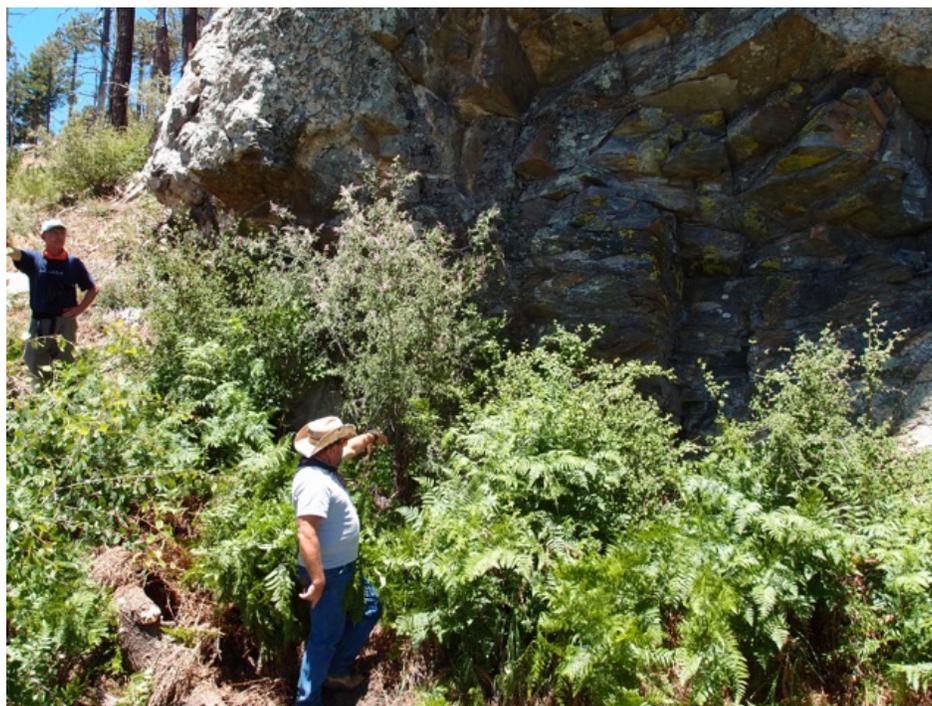
Fig 1 Brinkley Spring: mike pointing to the spring location

Management Recommendations: Where does the buried piping go? It must pre-date establishment of wilderness designation - check water rights records? If the spring water is no longer being utilized for modern humans, maybe the concrete and piping could be removed so wildlife could benefit from the spring.

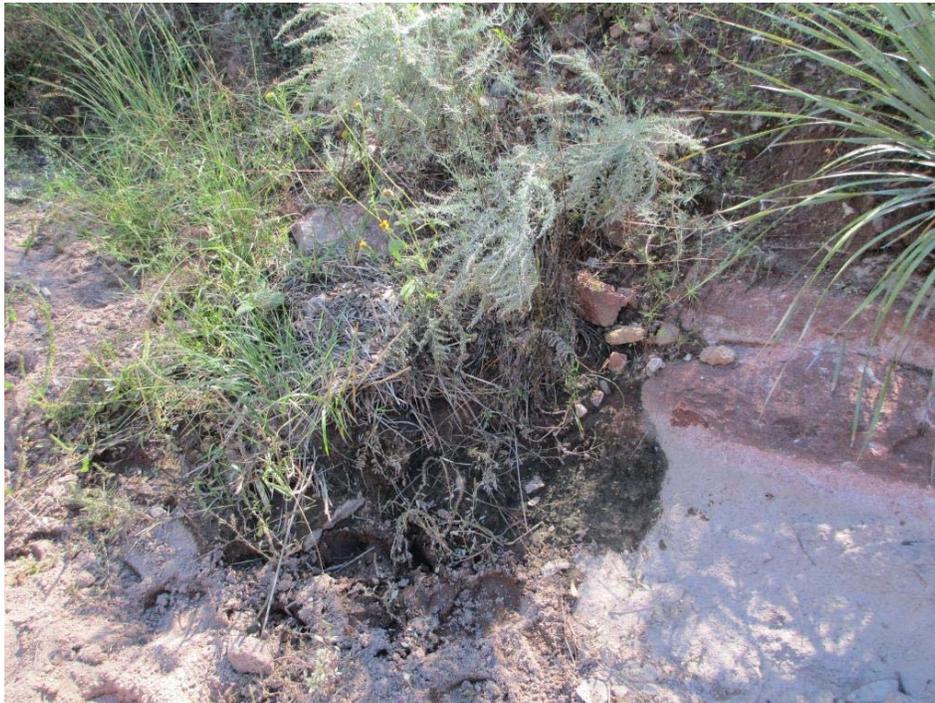
Fig 1 Broken Arm Spring: Looking at the seep on the west bank of channel.

Physical Description: Broken Arm Spring is a rheocrene spring. This spring is a wet seep emanating from the bank of a drainage channel bottomed with a combination of bedrock and sandy soils. The site has 1 microhabitat, X -- a 1 sqm backwall.

Management Recommendations: The site could be fenced off from cattle and be anchored with rocks to restart the accumulation of soils.

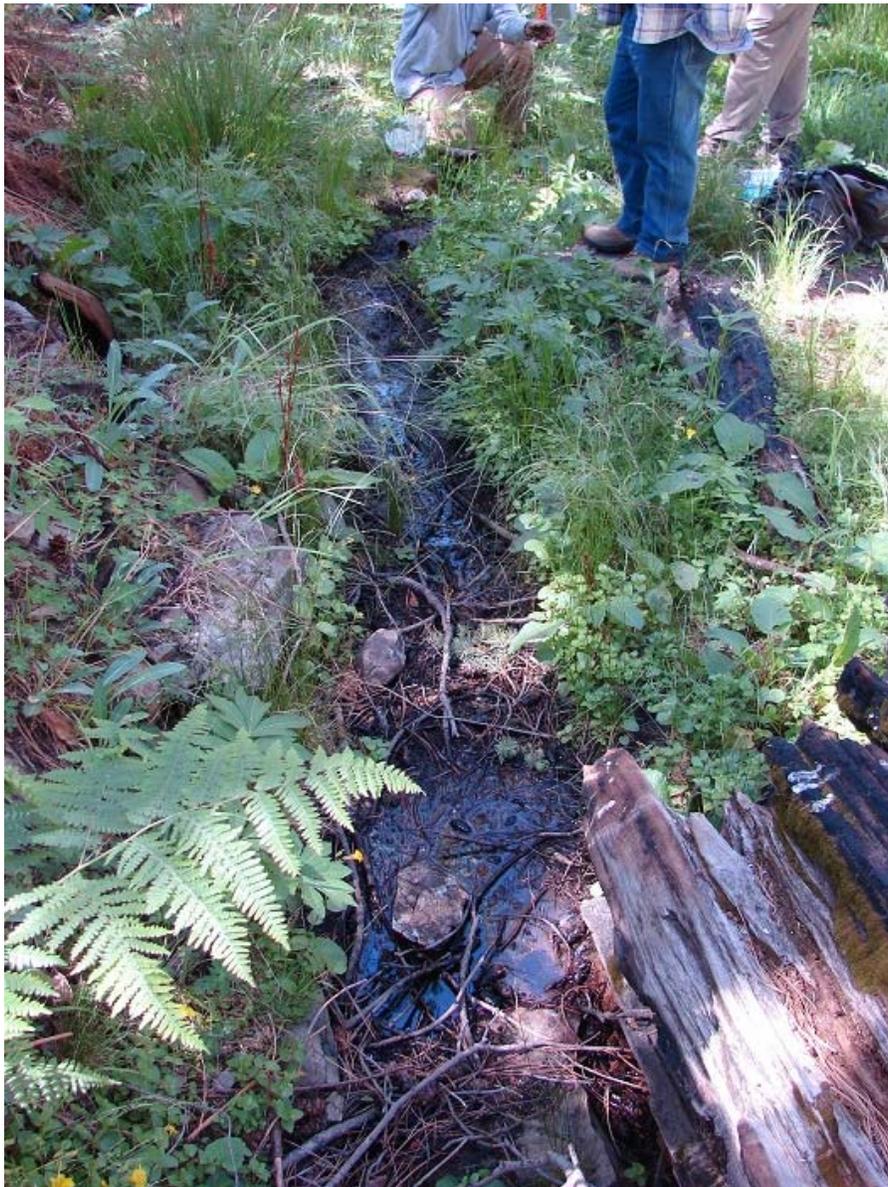
Fig 1 Cascade Spring.

Survey Notes: The spring has been totally developed. The surveyors followed the drainage down from the original spring coordinates; they found a small puddle, then a dry stretch, and then water at 519771, 3588919, 2708m elevation. This was where the solar pathfinder was used. Road construction and plumbing/piping of the spring has caused erosion and headcutting above the road and potentially caused the spring to migrate downstream.

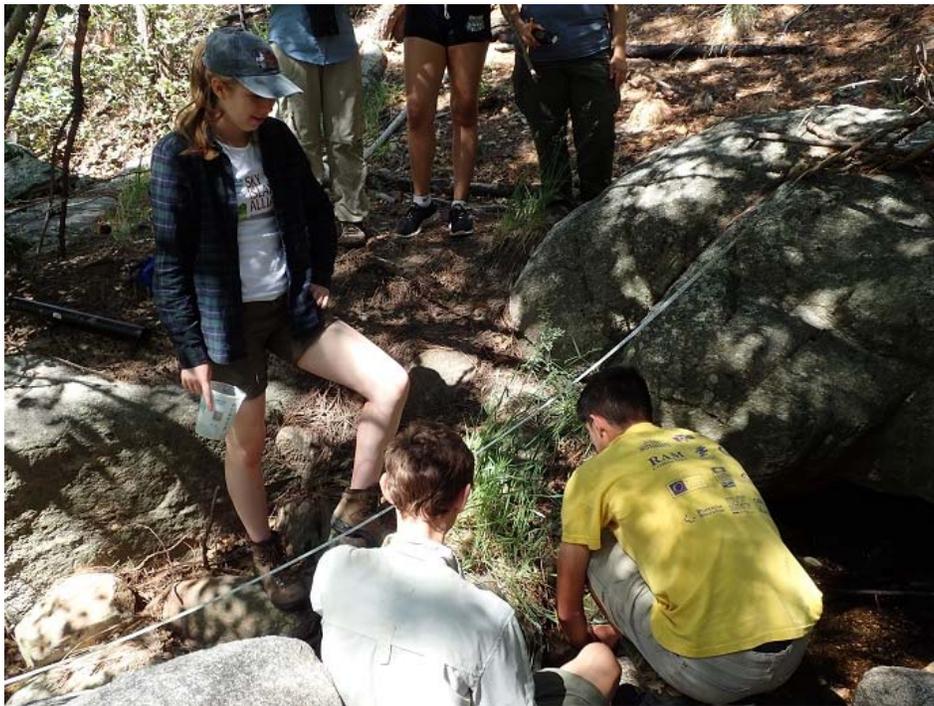
Fig 1 Caseco Spring.

Survey Notes: The site was in good condition. There was only a few small pieces of trash from the road. The area does not seem to get much traffic/use. There was some incision in the channel, probably some invasive grass species, and some trees had been cut in the past (not recently). It had substantial flow even in late June.

Management Recommendations: The road looping around the site poses a risk to the spring - there is some incision in the channel that may be due to road influence. There is also the helipad in close proximity. We saw a few pieces of trash. Ideally, the site should be monitored for any problems due to the road, particularly erosion-related issues, and any issues that occur should be addressed. The road does have a locked gate, so that is helpful.

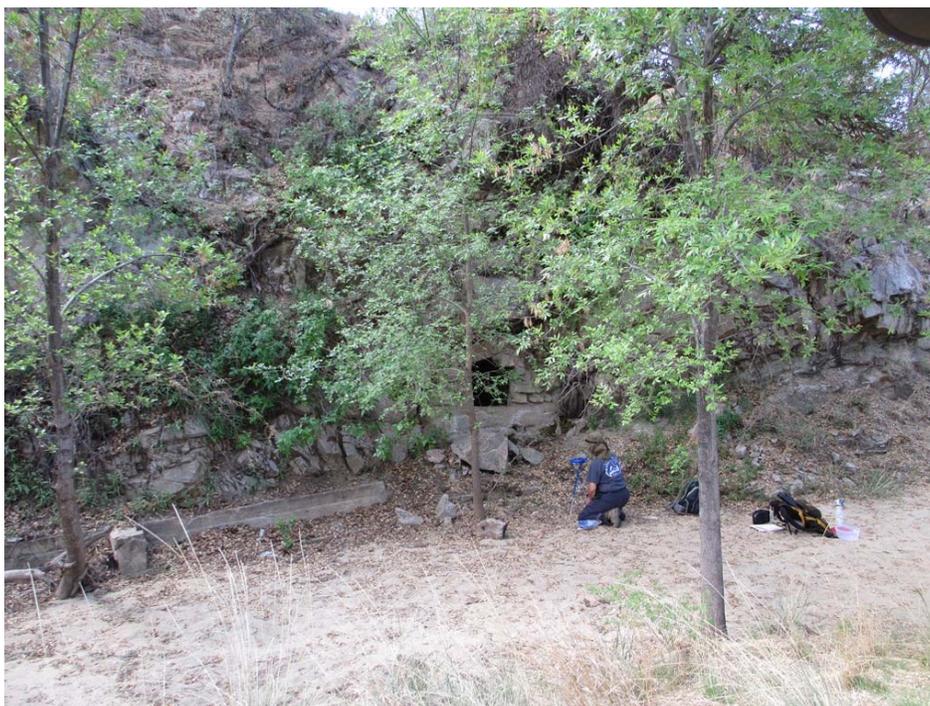
Fig 1 Crescent Spring.

Survey Notes: There is water in what appears to be a mine shaft. The site is in good condition. Plastic piping leaves the adit and goes to the southwest along the creek. It seems that the mine shaft has probably altered flow at what used to be a hanging garden site, and there is a nearby well that is also negatively affecting the water quantity. The riparian habitat in the channel still looks very healthy right around the site. There is garbage in the water in the mine shaft.

Management Recommendations: This spring is very rich with birds and invertebrates. Protect this site - keep cows out to preserve the microhabitats and diversity. Close the spur road that leads to the spring.

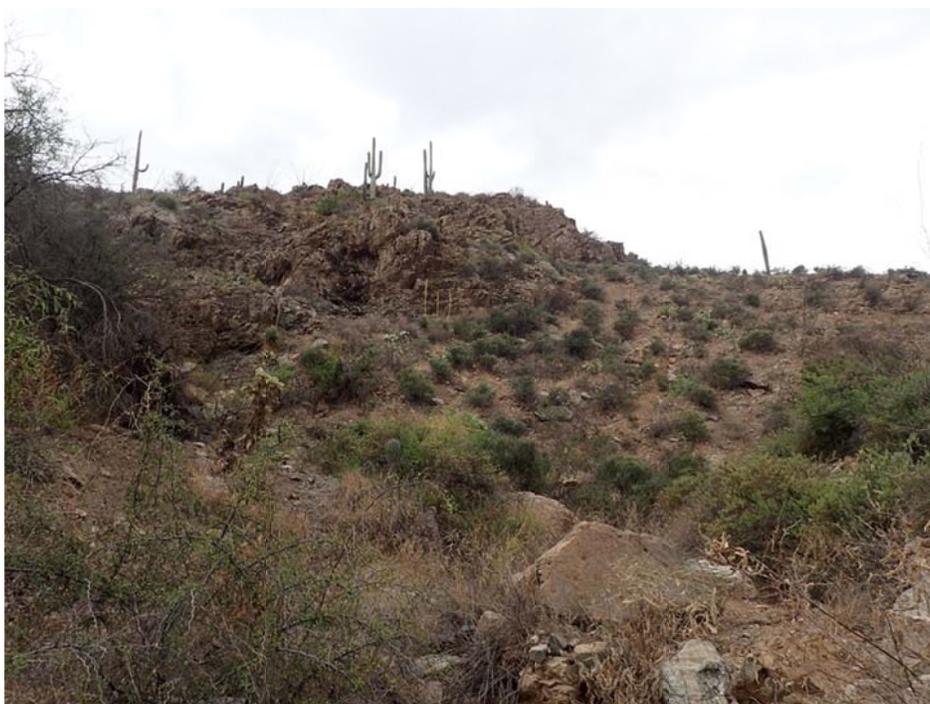
Fig 1 D-13-12 20DCB1: view of point from below, dark stains visible

Survey Notes: We did not find a spring. There is a mine adit within 100m. There are black stains on the rocks near the point - perhaps indication of water in the past? The coordinates were on a hillside, a bit below a rock outcrop. After returning from the field, Sami noticed a strange bare area on Google Earth about 100m to the ESE that may be related to a spring.

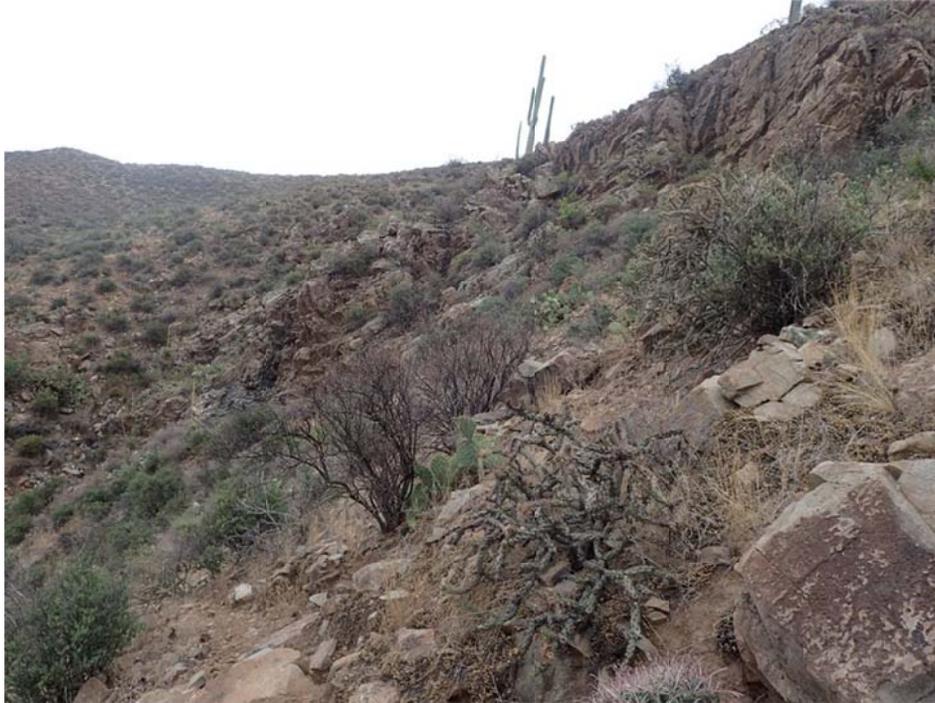
Fig 2 D-13-12 20DCB1: hillside by point - more dark marks

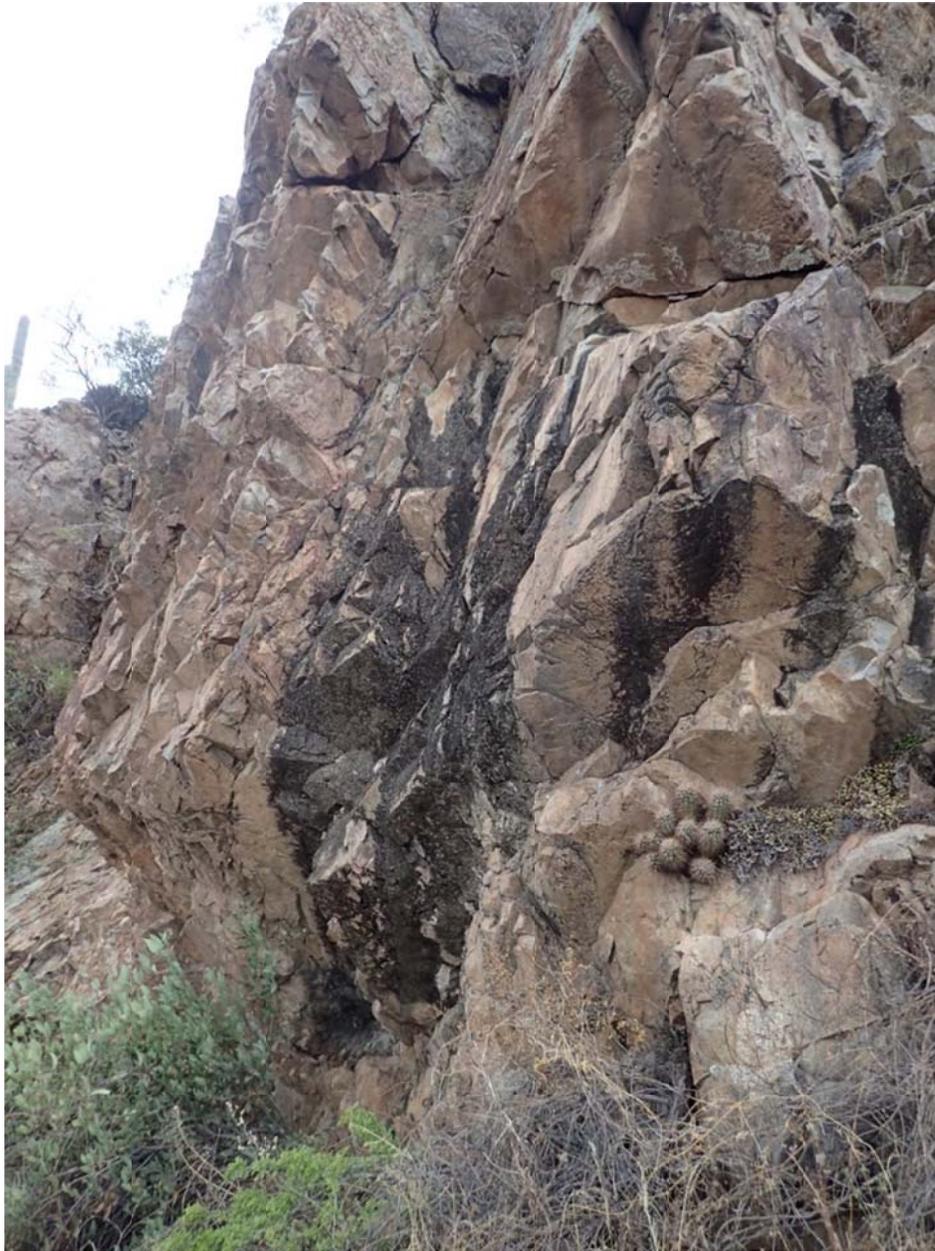
Fig 4 D-13-12 20DCB1: possible water stains close up

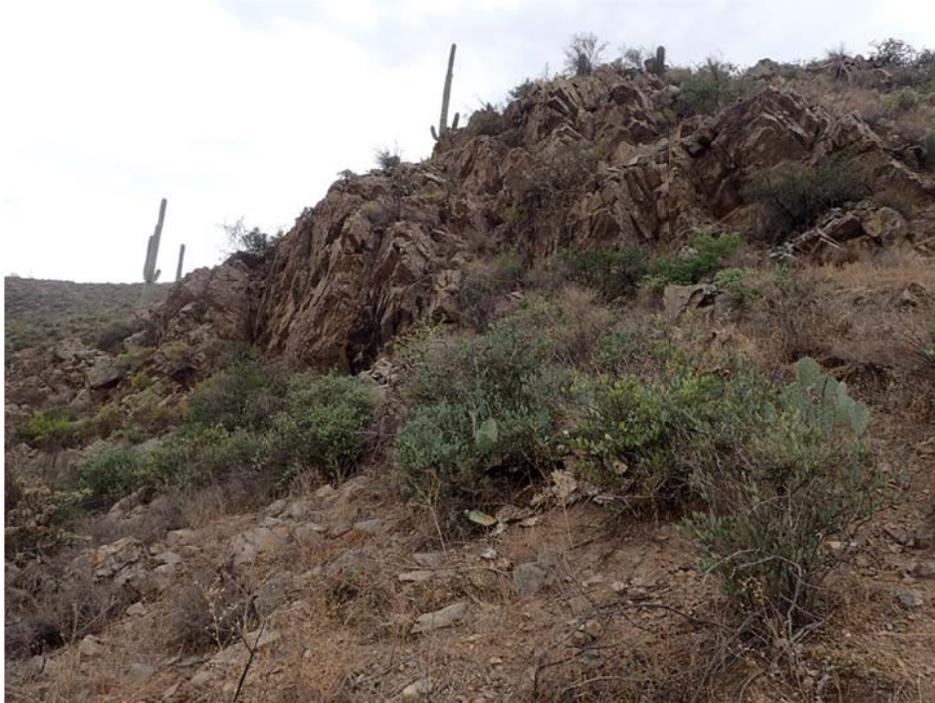
Fig 5 D-13-12 20DCB1: another view with dark stains

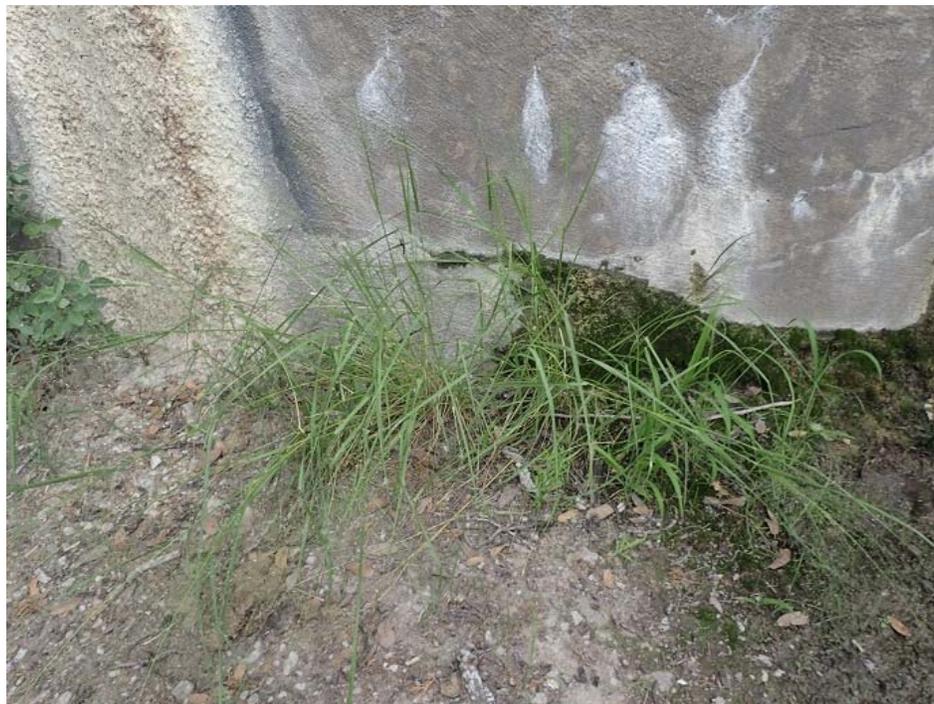
Fig 2 Deering Spring: leak from tank creating spring habitat

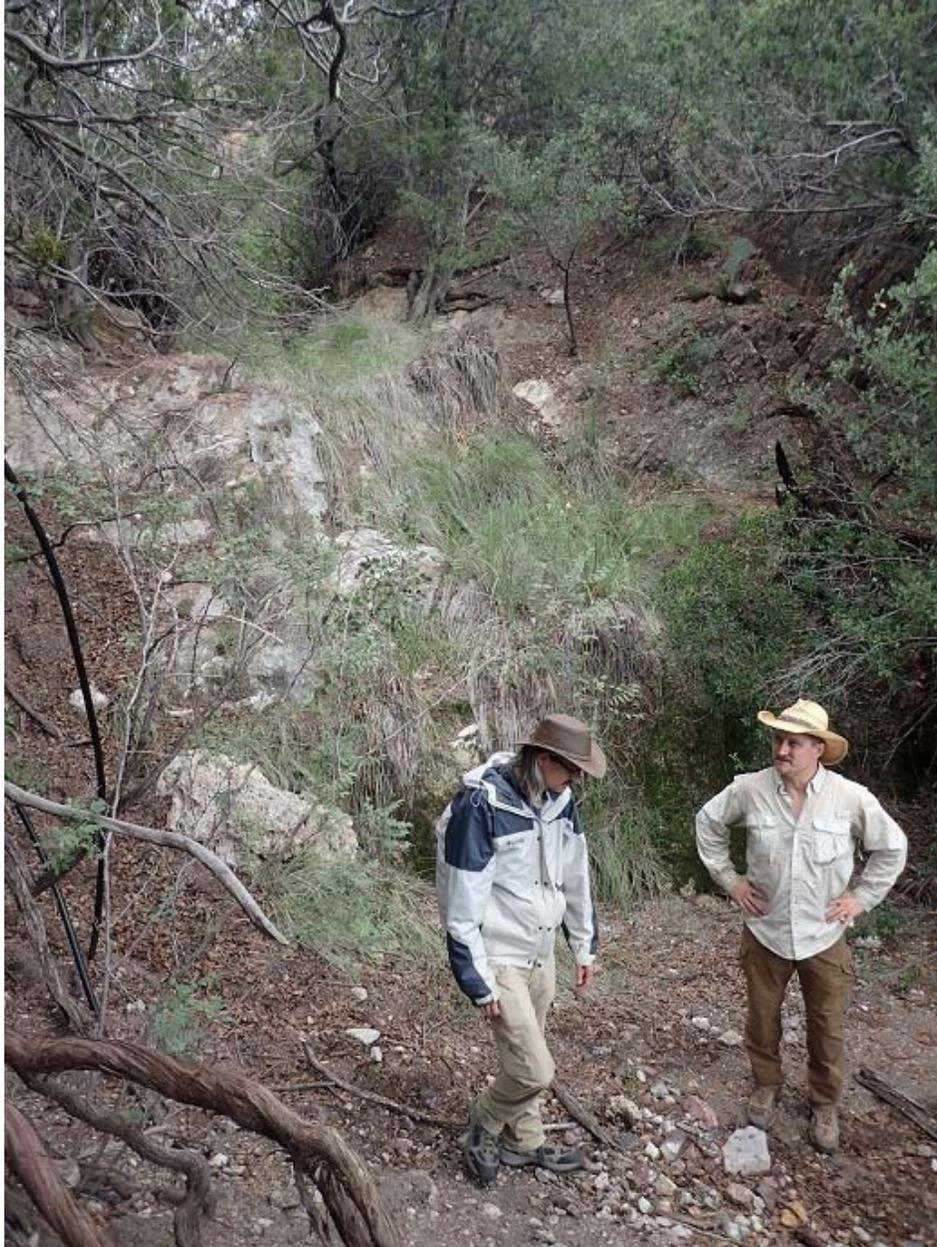
Fig 3 Deering Spring: fall in stream, covered in travertine deposits

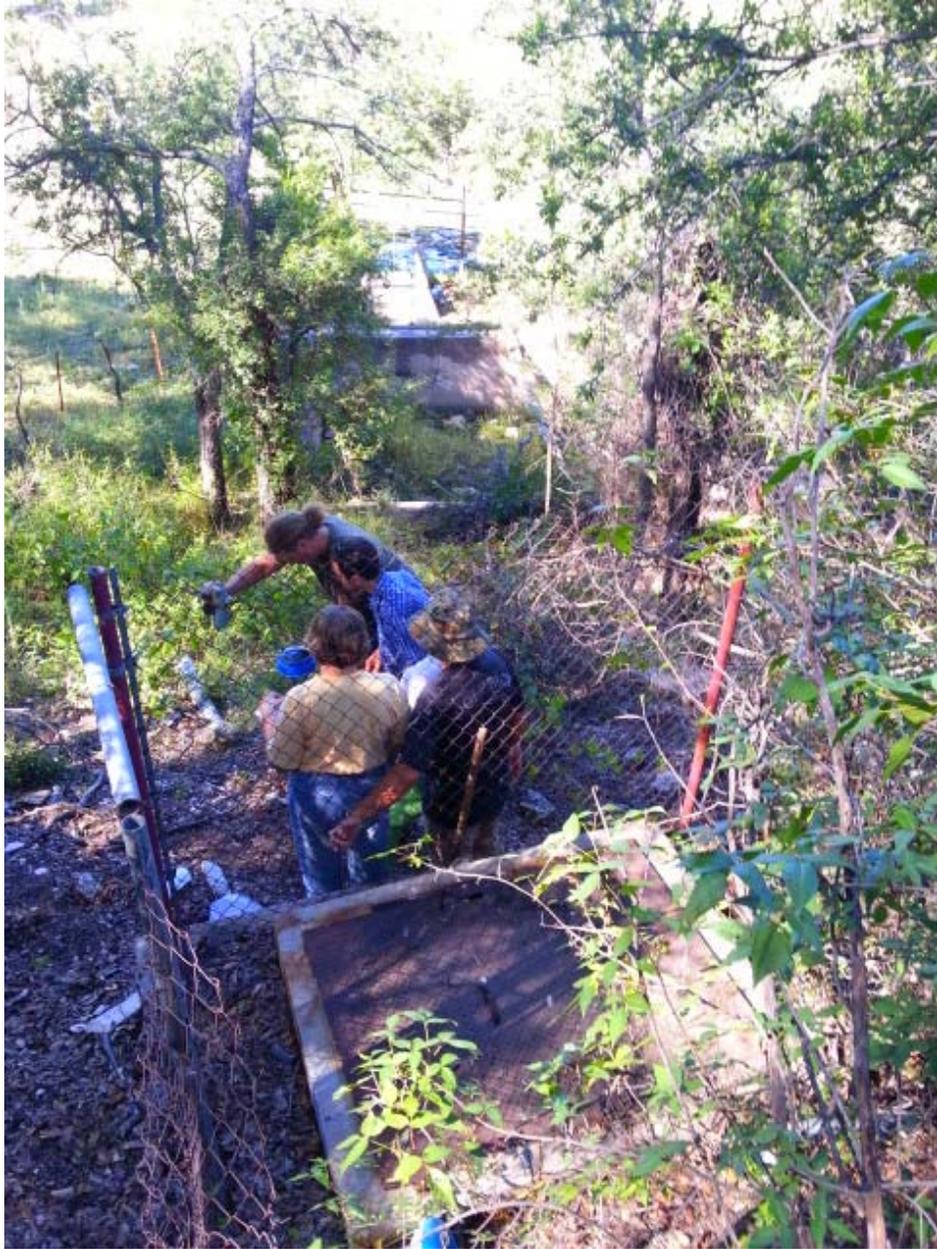
Fig 3 Pena Blanca Spring *: Diverted spring site. Looking downslope to trough, dry spring box, and corral.

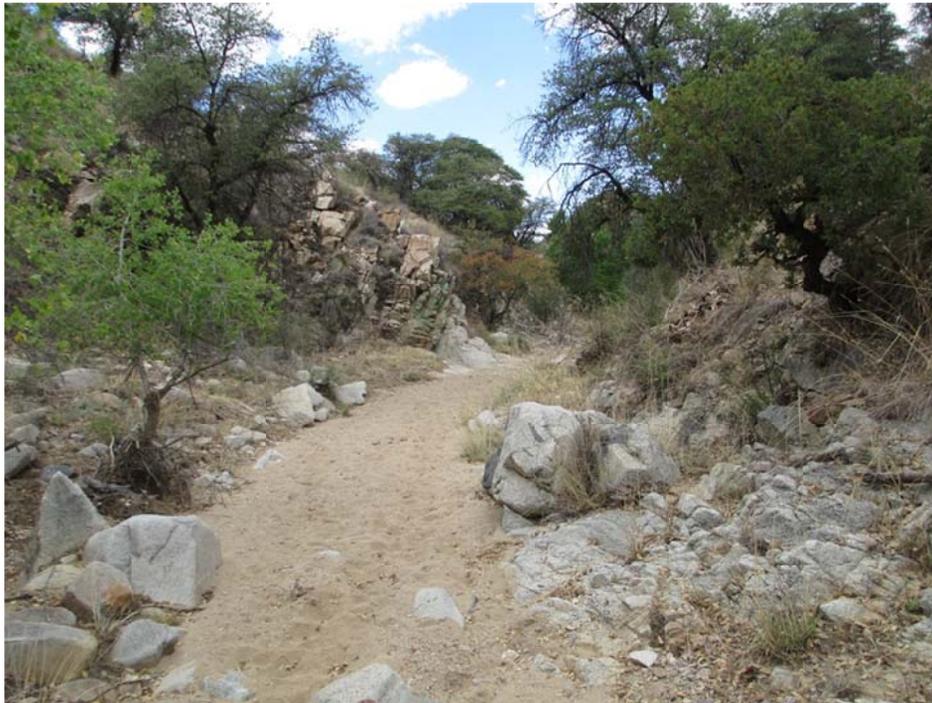
Fig 1 Shannon Spring: dry channel at spring coordinates
