Appendix C: Spring Inventory and Assessment Reports for Springs Surveyed for Fire Effects

Springs outside of the Upper Santa Cruz River Basin used in Fire Effects and Fuels Analysis

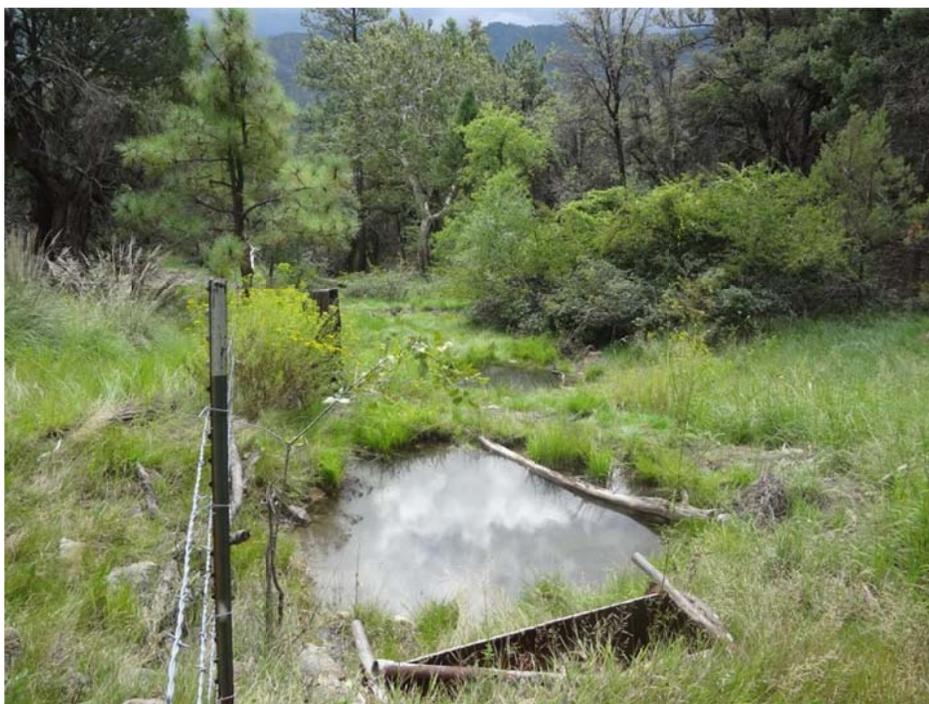
Fig 1 Ash Spring: View looking downchannel at upper, middle, and lower ponds.

Assessment: Assessment scores were compiled in 5 categories and 24 subcategories, with 18 null condition scores, and 18 null risk scores. Aquifer functionality and water quality are good with significant restoration potential and there is low risk. Geomorphology condition is good with significant restoration potential and there is low risk. Habitat condition is good with significant restoration potential and there is moderate risk. Biotic integrity is good with significant restoration potential and there is low risk. Human influence of site is good with significant restoration potential and there is low risk. Administrative context status is undetermined due to null scores and there is undetermined risk due to null scores. Overall, the site condition is good with significant restoration potential and there is low risk.

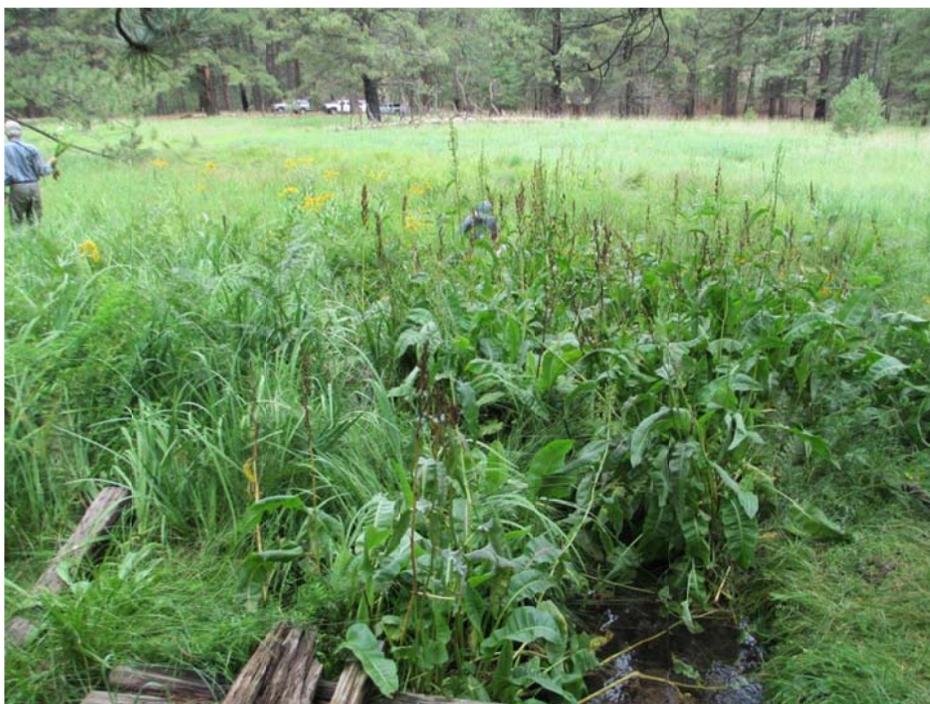
Fig 1 Barfoot Spring.

Assessment: Assessment scores were compiled in 5 categories and 25 subcategories, with 17 null condition scores, and 17 null risk scores. Aquifer functionality and water quality are very good with excellent restoration potential and there is negligible risk. Geomorphology condition is good with significant restoration potential and there is low risk. Habitat condition is good with significant restoration potential and there is low risk. Biotic integrity is very good with excellent restoration potential and there is low risk. Human influence of site is good with significant restoration potential and there is low risk. Administrative context status is undetermined due to null scores and there is undetermined risk due to null scores. Overall, the site condition is good with significant restoration potential and there is low risk.

Management Recommendations: Continue to monitor the perimeter fencing to keep cows out. If possible, monitoring water flow would help understand the response surrounding habitat to fire and to climate change.

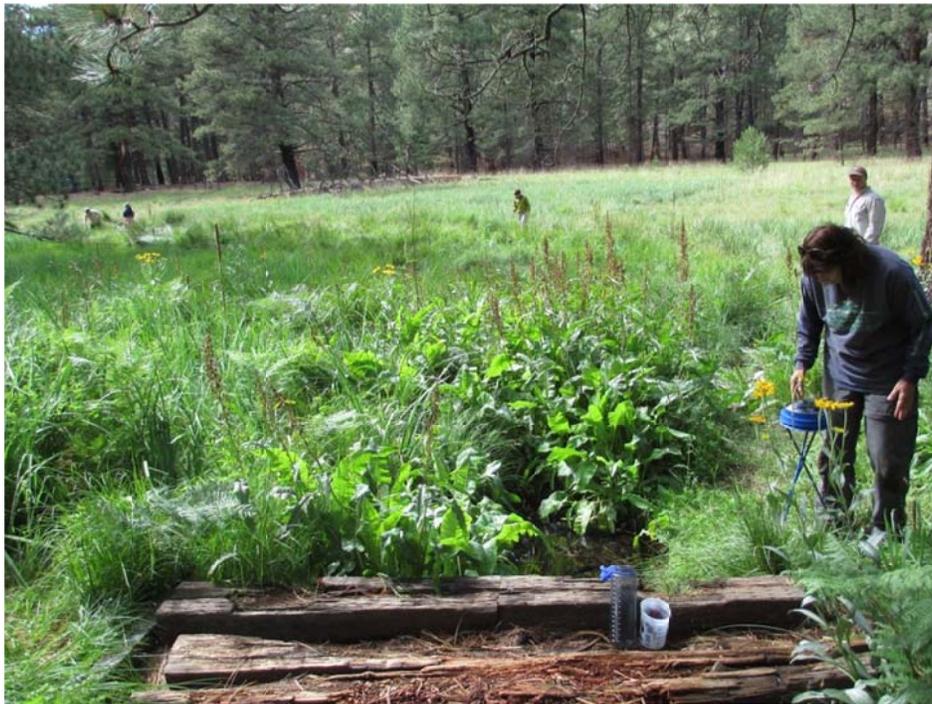
Fig 1 Barfoot Spring: Looking down to the open meadow

Assessment: Assessment scores were compiled in 5 categories and 25 subcategories, with 17 null condition scores, and 17 null risk scores. Aquifer functionality and water quality are very good with excellent restoration potential and there is negligible risk. Geomorphology condition is good with significant restoration potential and there is low risk. Habitat condition is good with significant restoration potential and there is low risk. Biotic integrity is very good with excellent restoration potential and there is low risk. Human influence of site is good with significant restoration potential and there is low risk. Administrative context status is undetermined due to null scores and there is undetermined risk due to null scores. Overall, the site condition is good with significant restoration potential and there is low risk.

Management Recommendations: Some of the fencing around the site is in disrepair. It's highly recommended that the perimeter fence be adequately maintained to preclude access to cows. The site has been modified via digging pools to allow bats access to water. We recommend that this practice be discontinued unless the wet meadow habitat can be left undisturbed.

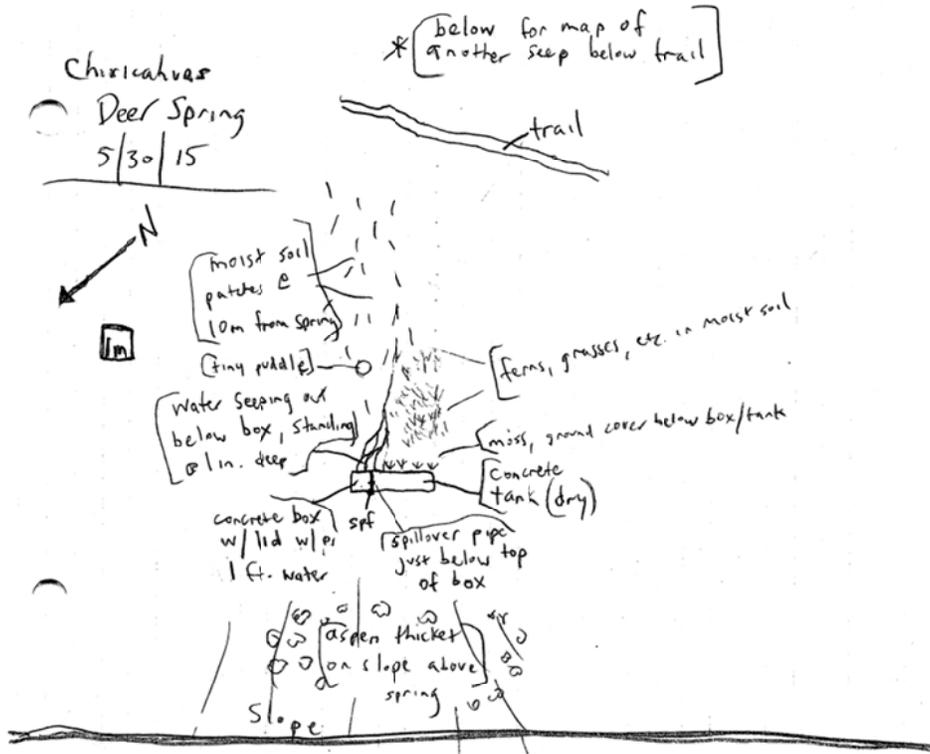
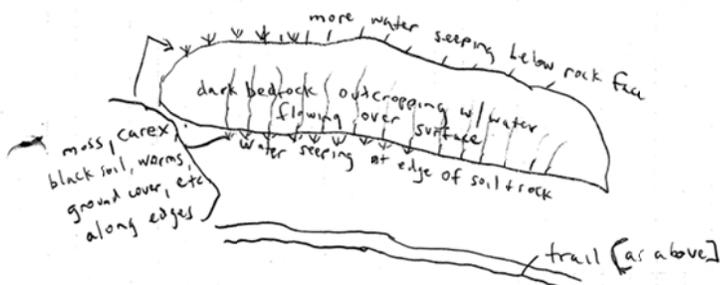
Fig 2 Deer Spring Sketchmap.

Survey Notes: The site is on a severely burned steep slope. It is barely flowing. There is some aspen regeneration happening right above the spring.

Management Recommendations: Site is on very steep slopes in an area that burned severely. It is being effected by erosion, is developed for human use and continues to be used by backpackers in the wilderness. Site is suffering erosion due to the surrounding land condition and is believed to be significantly dewatered due to the loss of canopy cover and other alterations post fire. The site could benefit from upslope erosion control, a trail to send backpackers to the box in the least erosive way, and possibly from restoration of the diversity of plant species you might expect at this type of site. It has lost much of its function as a microhabitat

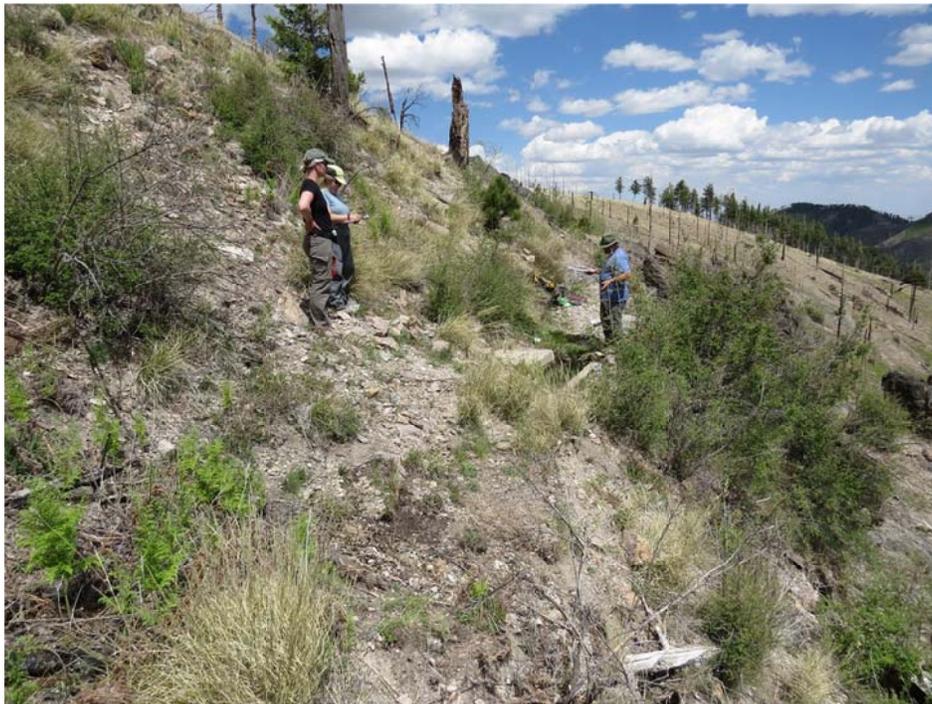
Fig 1 Eagle Spring: view with northern seep in foreground, springbox farther away

Physical Description: Eagle Spring is a hillslope spring. It is a boxed spring on a steep southwest-facing slope with a spur trail to it. There is a covered spring box with an openable cover, which has a hole in the side from which water flows into the trough. Water then overflows the trough and continues down the steep hillside in a bit of a channel. There is an undeveloped seep 6m away from the box. The site has 3 microhabitats, including A -- a 1 sqm pool, B -- a 5 sqm channel, C -- a 3 sqm wet hillslope.

Management Recommendations: The source is boxed, destroying the original emergence microhabitat (but creating a new one). The area is heavily burned around and above the site - there is some potential for slope failure or erosion to damage or destroy the site. It may be a good idea to protect the site from this in some way.

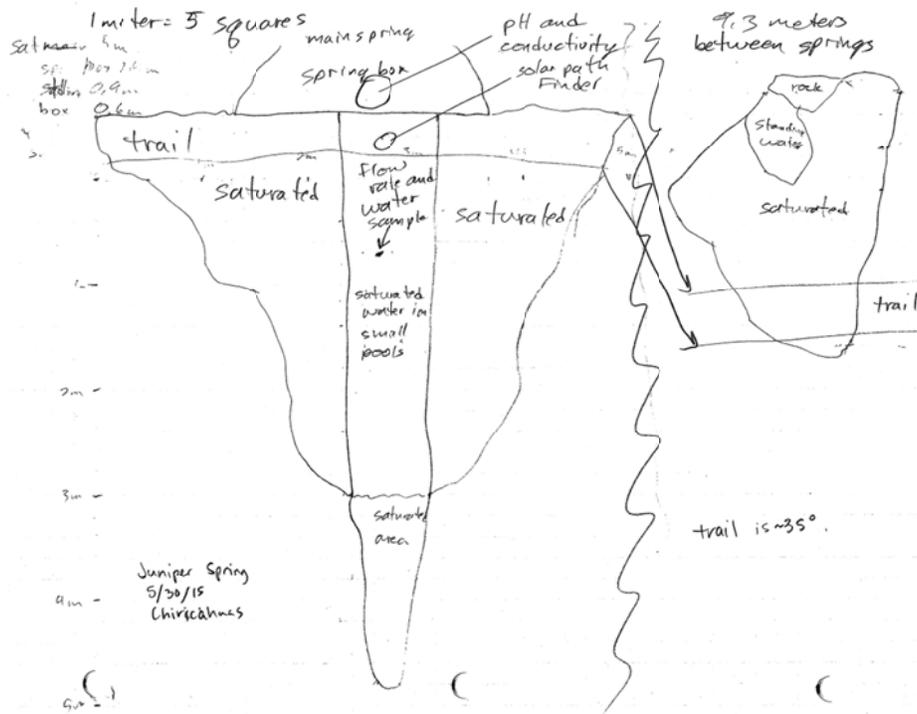
Fig 2 Juniper Spring Sketchmap.

Survey Notes: The site is on the edge of a burn area. The southern-most spring box is dry and disconnected (pipe broken).

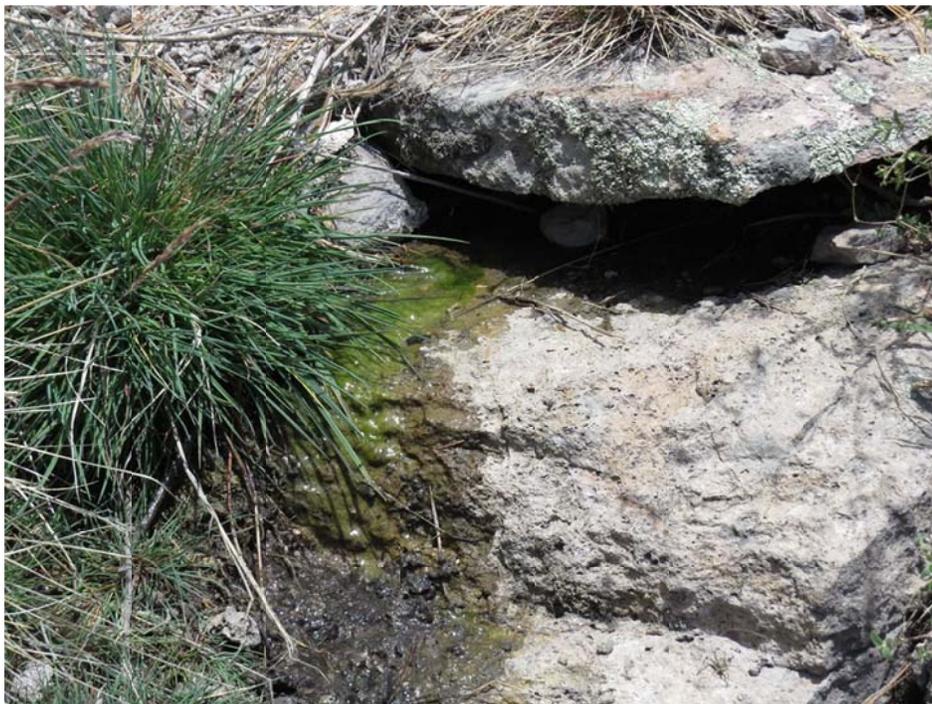
Fig 3 Juniper Spring: upper seep close up

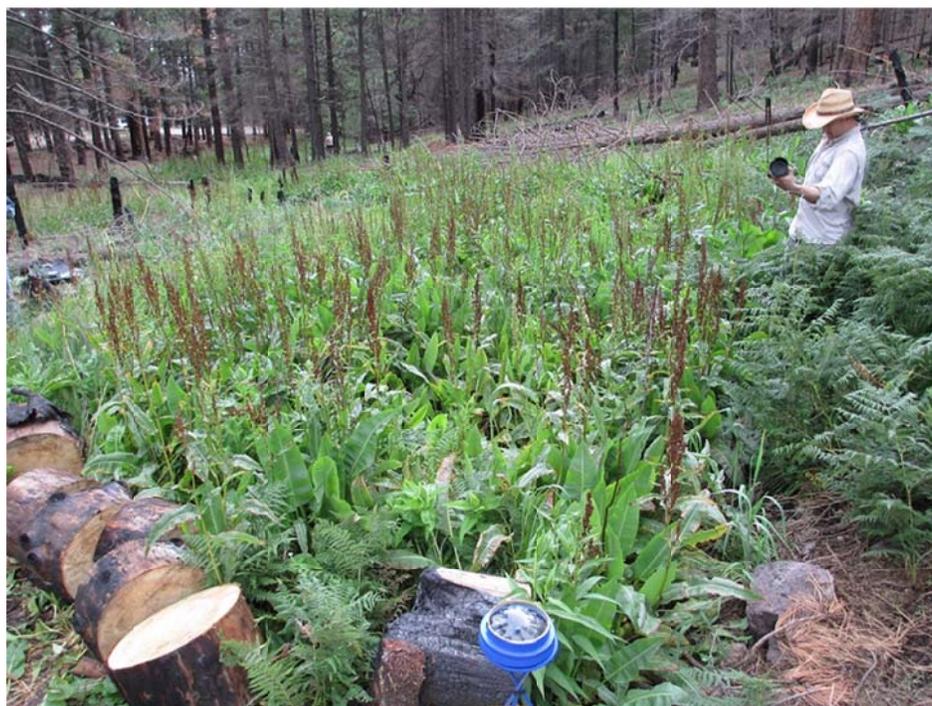
Fig 1 Lower Rustler Spring: spring origin

Survey Notes: At the time of the visit, the site is heavily disrupted from fire in 2011 and the USFS is actively cutting down burned trees - the vegetation is trampled from lots of (foot traffic?) crossings. At the time of the visit, burned trees were actually down and being cut across the spring run.

Management Recommendations: The spring is in an area that burned severely. The USFS is actively cutting down burned trees all around the site. At the time of the visit, burned trees were actually down and being cut across the spring run. Also within a popular developed campground near the road in. The springs is the source of a stream that continues down the mountain. Although the forest is burned all around the spring emmersion, there are areas upslope that have not burned.

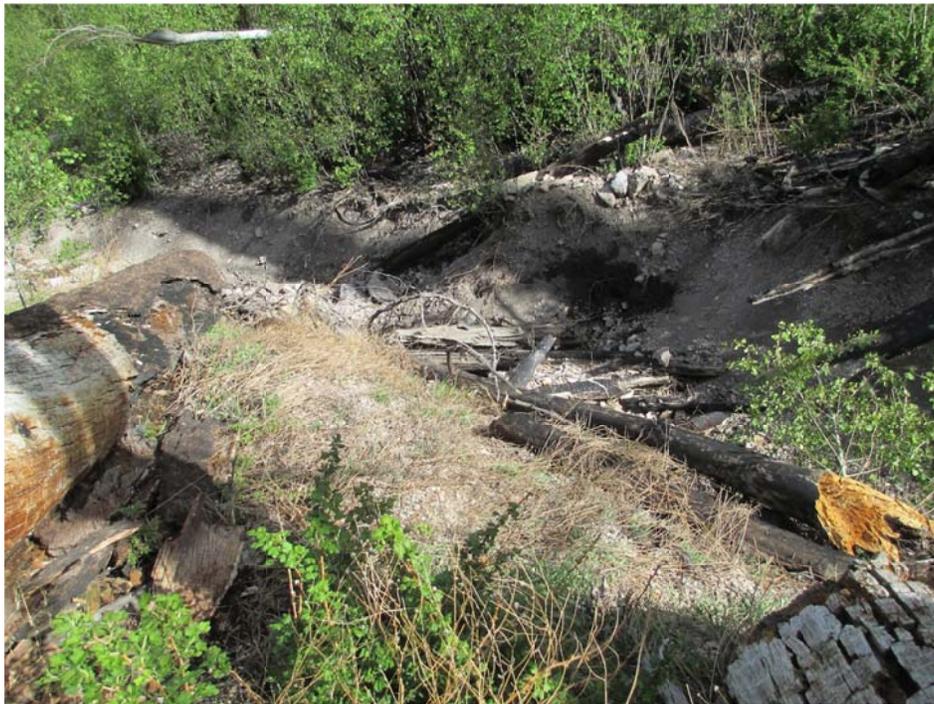
Fig 1 Ojo Agua Fria.

Physical Description: Ojo Agua Fria is a hillslope spring in a steep area just above a small drainage. Spring emerges from hillslope where it is boxed then flows into a channel. The site has 2 microhabitats, including A -- a 2 sqm pool, B -- a 52 sqm channel.

Management Recommendations: Spring is located in Chiricahua Wilderness in an area that has burned severely in the last few years. Slopes above the spring are primarily aspen regrowth. Mature pine/conifer canopy cover at the site has been lost due to fire. The site is developed and appears to be maintained. There were some erosion control measures taken near the spring box. Spring is used by hikers/backpackers. There is a sign and trail leading to the spring. Upslope instability and channel down cutting near the spring will continue to be a problem. The spring may have previously supported more robust in-channel riparian/aquatic habitat and may still be able to do that while providing water for hikers if the structure is modified.

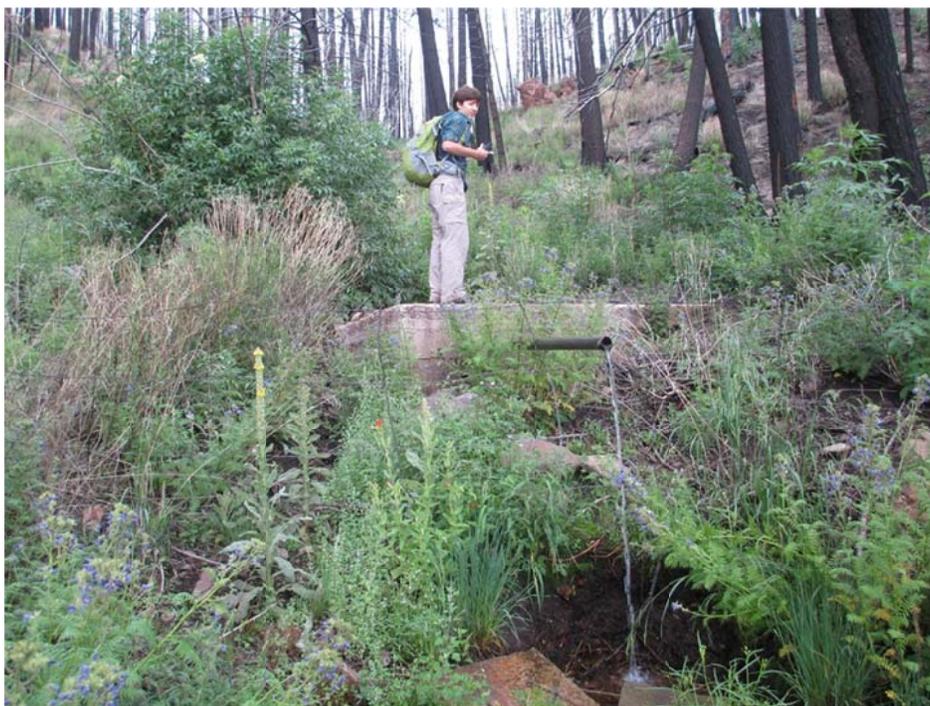
Fig 1 Upper Rustler Spring: source

Physical Description: Upper Rustler Spring is a hillslope spring that emerges on a steep slope above a mountain meadow in coniferous forest. The spring is boxed with a pipe emerging. The site has 2 microhabitats.

Management Recommendations: Trees at the site are marked with flagging - for FS removal? The spring is within the campground area where the FS is actively removing burned trees post-fire. There has been loss of canopy cover around the site due to fire and most of the trees surrounding and upslope of the site are dead. This may affect the spring over the long term including microhabitats and flow.

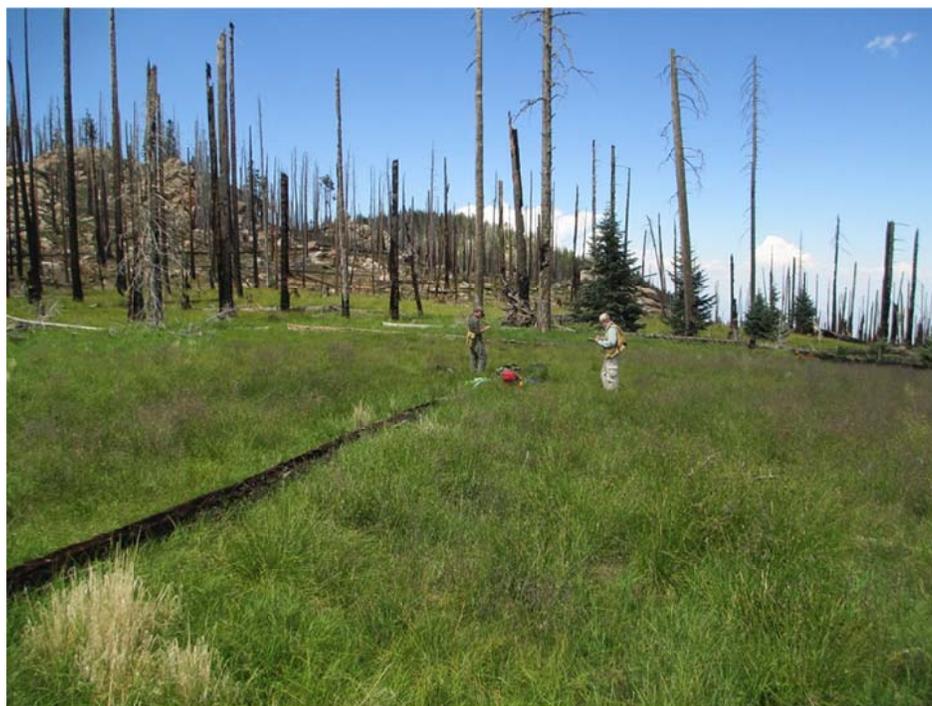
Fig 1 Emerald Spring.

Physical Description: Emerald Spring is a helocrene spring. There is a wet meadow in a burned area (2004) with scattered spruce/fir, but primarily open. The site has 2 microhabitats, including A -- a 2050 sqm high gradient cienega, B -- a 700 sqm channel.

Survey Notes: The spring is in the middle of a large burned area, although it appears the wet meadow area of the spring has always been tree-free. This site appears to be the only source of natural regeneration of spruce and fir in the surrounding landscape. The cienega has young spruce and fir around the edges of the wet meadow and along the runout channel. The site is 500m from the telescope and a road. No springsnail search was conducted.

Management Recommendations: Work with Tom VanDevender to locate field records from previous visits to the site both pre-burn and pre-beetle kill. Look at squirrel BO and Scoping EIS for any further information about flow and species presence before the fire. Talk with San Carlos and White Mountain Apache to understand the history and importance of the site to the tribes - they are known to be sacred sites as is the whole top of the mountain.

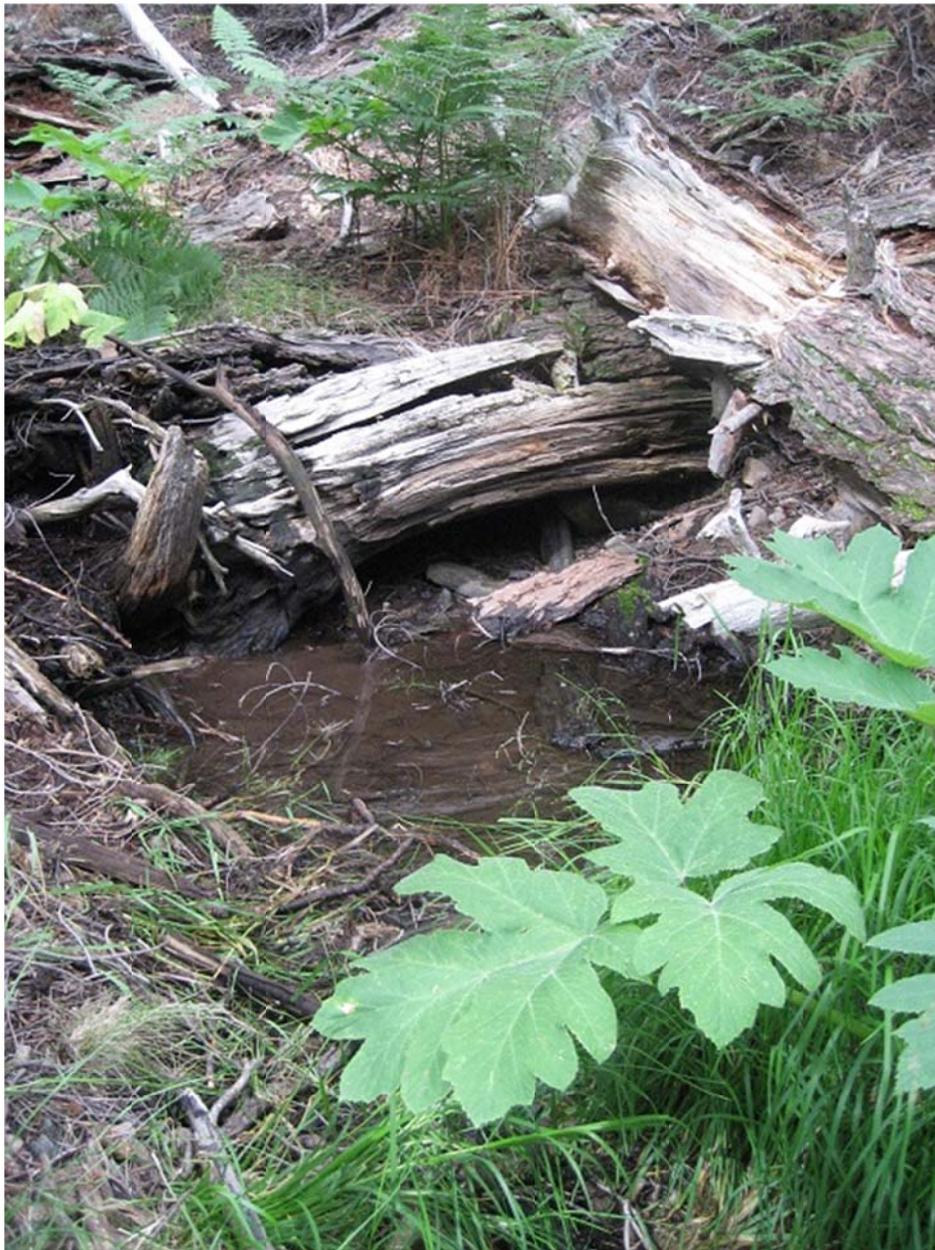
Fig 1 Hairpin Spring Unnamed.

Physical Description: Hairpin Spring Unnamed is a rheocrene spring. It is a small spring emerging in a steep, heavily wooded channel. The site has 1 microhabitat, A -- a 38 sqm channel.

Survey Notes: The spring is covered by logging or thinning debris - lots of downed wood. The road above the spring has likely altered its natural condition. The culvert above the spring is clogged and almost buried, which may cause the road to fail and destroy the spring.

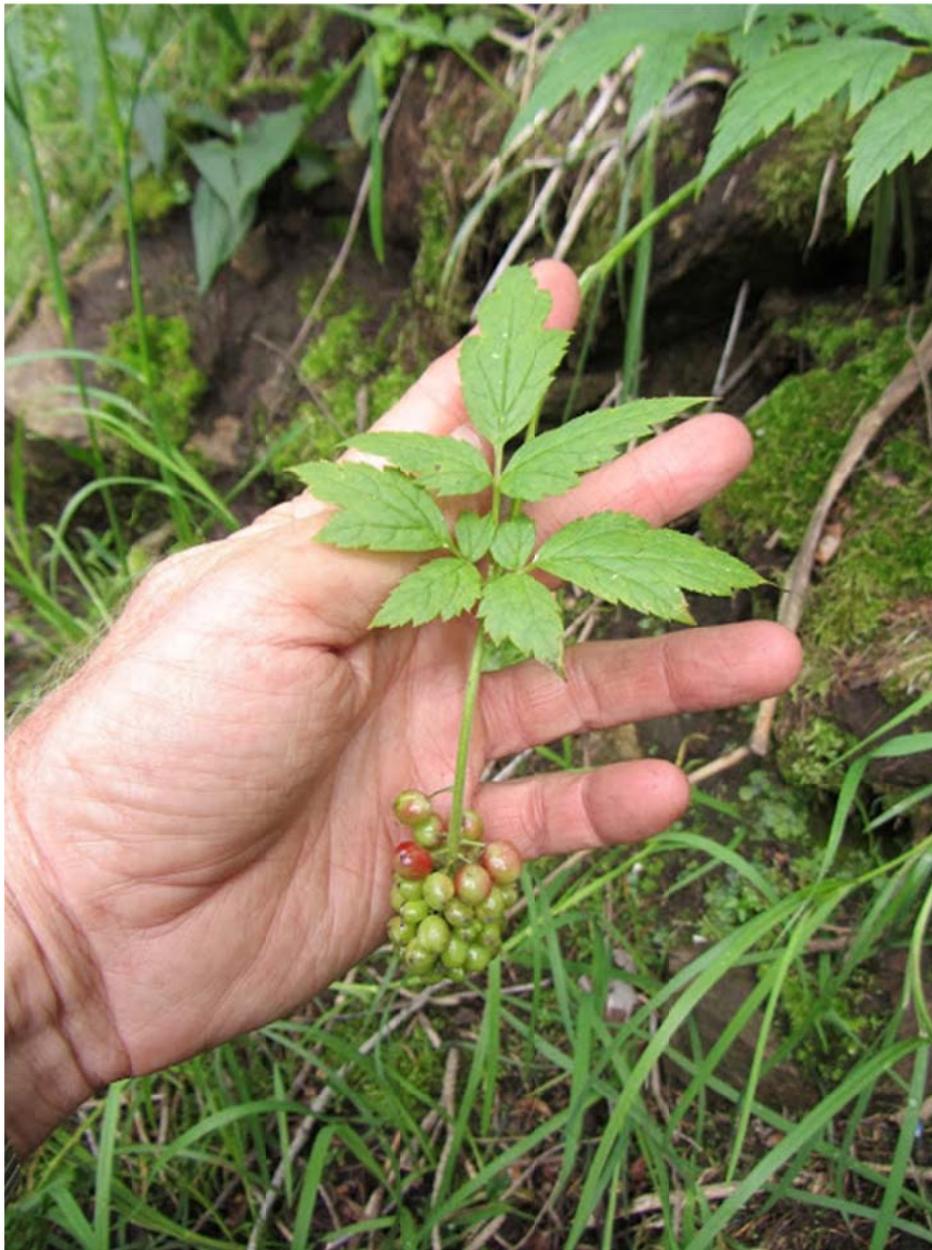
Fig 1.1 Heliograph Spring. Best available photo

Physical Description: Heliograph Spring is a hillslope spring. The site has a lidded/boxed hillside spring protected by several stone enclosures.

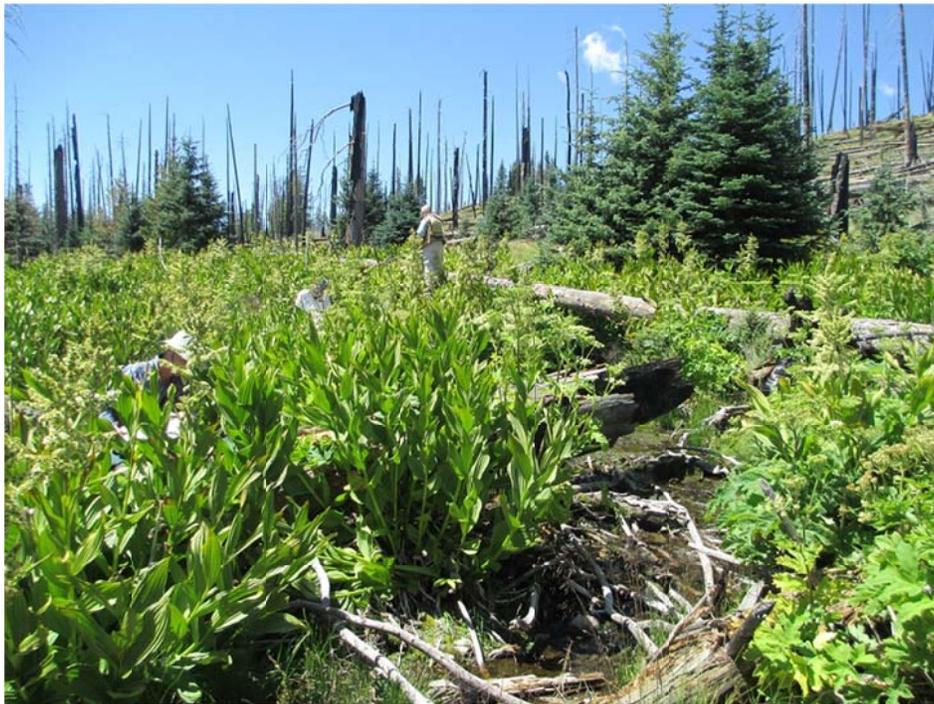
Fig 1 High Peak Cienega.

Physical Description: High Peak Cienega is a hillslope spring. The spring emerges from a hillside in a flat open meadow at the start of a drainage. The microhabitats associated with the spring cover 430 sqm. The site has 2 microhabitats, including A -- a 36 sqm channel, B -- a 394 sqm low gradient cienega. The geomorphic diversity is 0.12, based on the Shannon-Weiner diversity index.

Survey Notes: The site is in good condition. A large fire burned here in 2004 and the spring is the only site of regeneration of spruce and fir. The spring appears to be the only source of natural spruce/fir regeneration - all of the surrounding landscape burned in 2004, with no

Management Recommendations: Work with Tom VanDevender to find previous survey information from before 2004 fire, possibly from before beetle kill. Consult BO and telescope EIS for any previous flow information. Talk with San Carlos and White Mountain Apache about the cultural significance of the site.

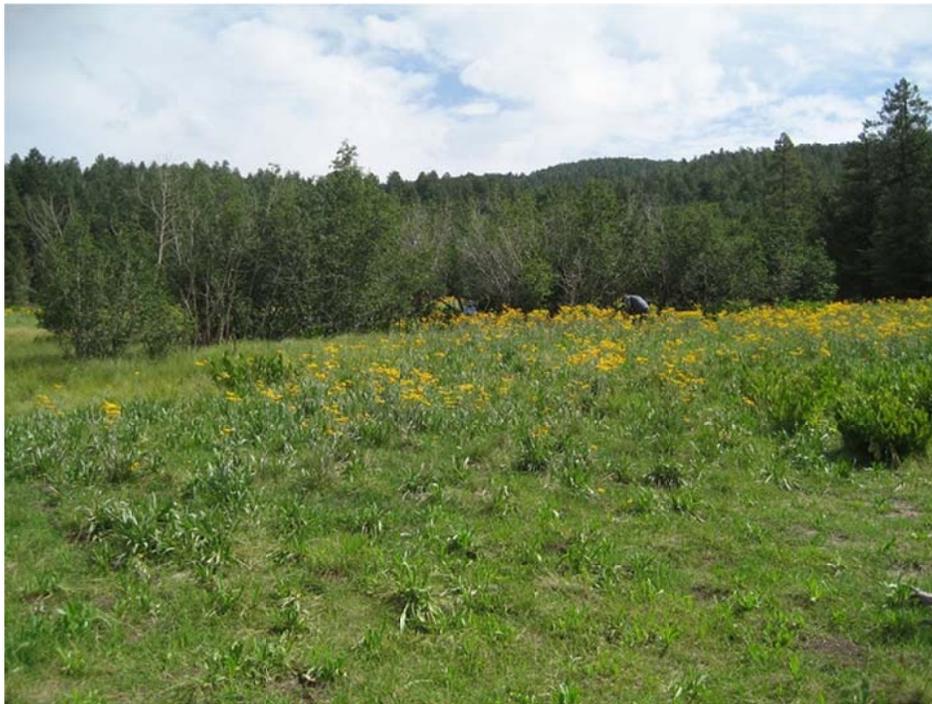
Fig 1 Unnamed.

Physical Description: Unnamed is a helocrene spring. The spring emerges from a large open meadow denoted by alder trees and a small channel. There is no open water. The site has 2 microhabitats, including A -- a 375 sqm channel, B -- a 1000 sqm low gradient cienega.

Survey Notes: The site is heavily used for recreation with signs of people driving through the meadow. This site is part of a larger helocrene complex with high quality wetland habitat - passed camping and driving - Road engineering has degraded the adjacent habitat (recent?).

Management Recommendations: This site is part of a larger helocrene complex with high quality wetland habitat - passed camping and driving - Road engineering has degraded the adjacent habitat (recent?). The site could benefit from restoration and engineering.

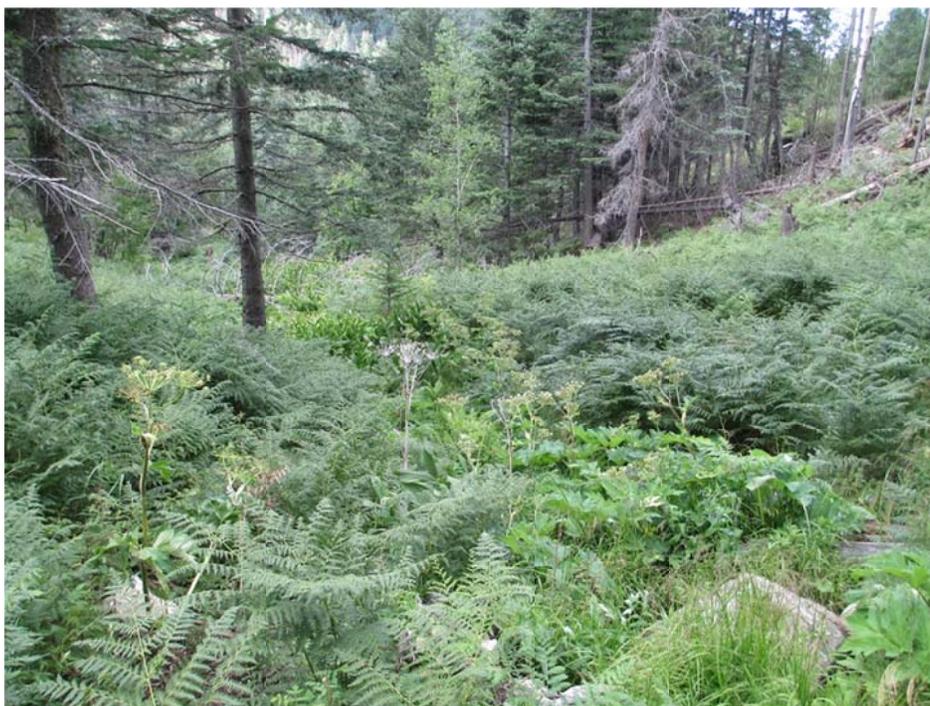
Fig 1 Shannon Campground Unnamed.

Physical Description: Shannon Campground Unnamed is a rheocrene/helocrene spring. This site is nearly pristine. It has a faint channel, so is likely a rheocrene site.

Management Recommendations: The spring is quite natural and has good vegetative cover and normal flow. An abandoned (logging) road leads out to the spring area. No more vehicles area accessing the area above the spring, allowing the road to revegetate. From the looks of it, it doesn't get a lot of foot traffic either.

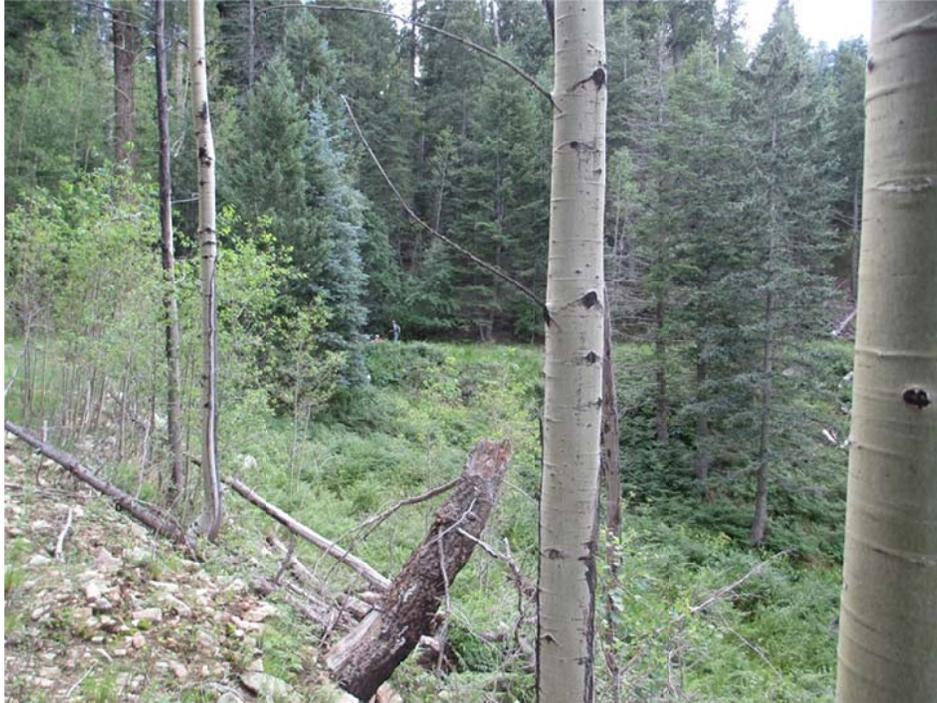
Fig 3 Shannon Campground Unnamed: spring in its surroundings - spring is where people are standing

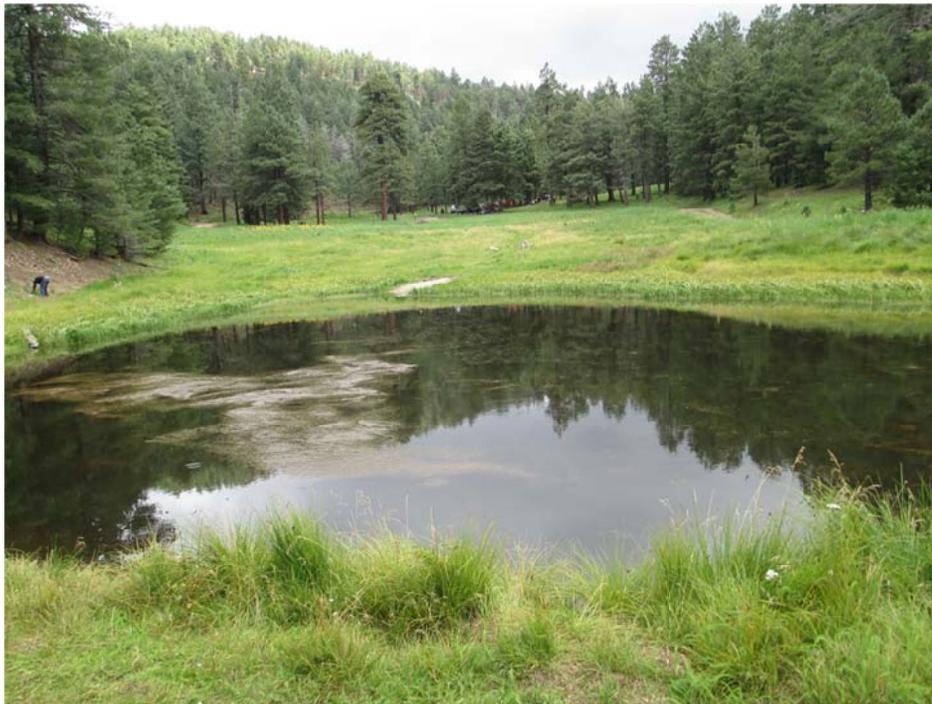
Fig 1 Snow Flat Unnamed.

Physical Description: Snow Flat Unnamed is a helocene/anthropogenic spring. There is a wet meadow which drains to a small dammed pool. The site has 5 microhabitats. The geomorphic diversity is 0.00, based on the Shannon-Weiner diversity index.

Management Recommendations: The dam is creating an unnatural pond. A spillway is causing erosion in the runout channel. There are extensive road and trail impacts around the spring that could be mitigated. Dispersed recreation is heavily impacting the spring and

surrounding areas. A better designed campground and restoration of impacted areas would be beneficial.

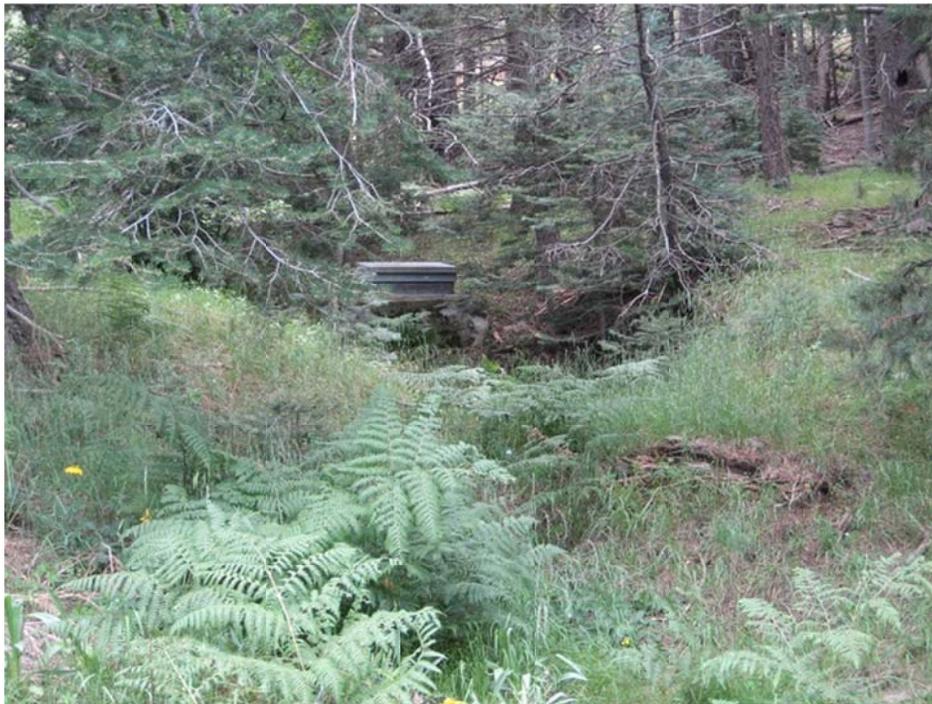
Fig 1 Unnamed.

Physical Description: Unnamed is a hillslope spring. It is a developed spring in a small drainage near the Treasure Park campground. It is the water source for the campground. The site has 2 microhabitats, including A -- a 1120 sqm channel, B -- a 1200 sqm adjacent uplands.

Management Recommendations: Due to the presence of overflow from the storage tank, it may be possible to rewater the historic wetlands at the site.

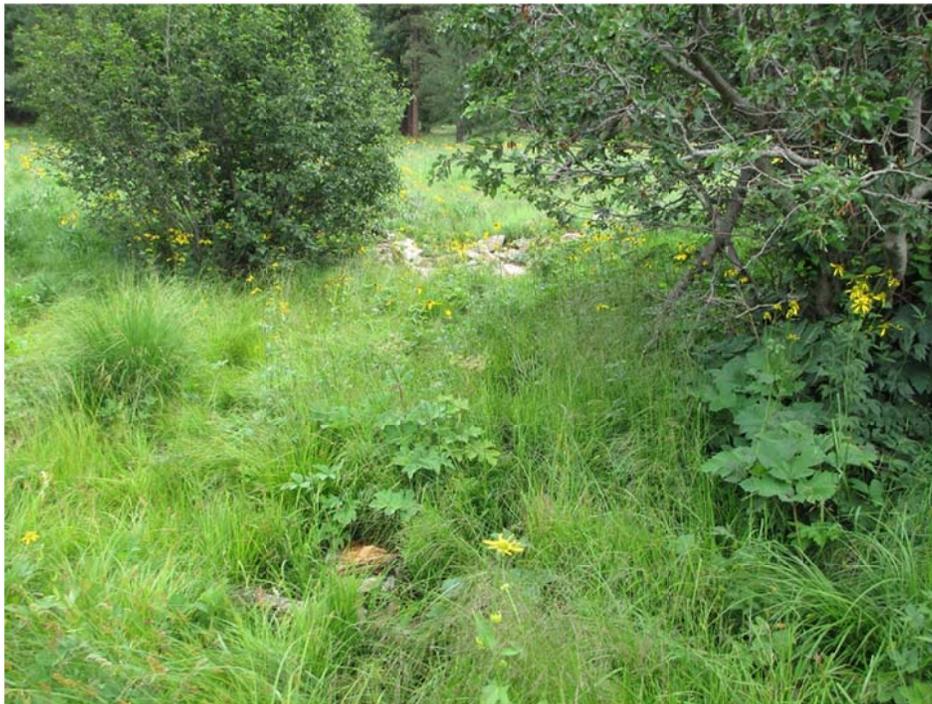
Fig 1 Unnamed.

Physical Description: Unnamed is a helocrene spring that is part of a larger complex. It is located in an open meadow in an undeveloped campground area. The microhabitat associated with the spring covers 1300 sqm. The site has 1 microhabitat, A -- a 1300 sqm high gradient cienega. The geomorphic diversity is 0.00, based on the Shannon-Weiner diversity index.

Management Recommendations: The FS road nearby massive ditch digging above spring dug out channel. The piled up rock at spring source may be to prevent a head cut? The site could use fencing to keep motorized users out - there are lots of motorized traffic (quads, etc.) tire tracks through meadow. There is an old campground in the middle of the meadow.

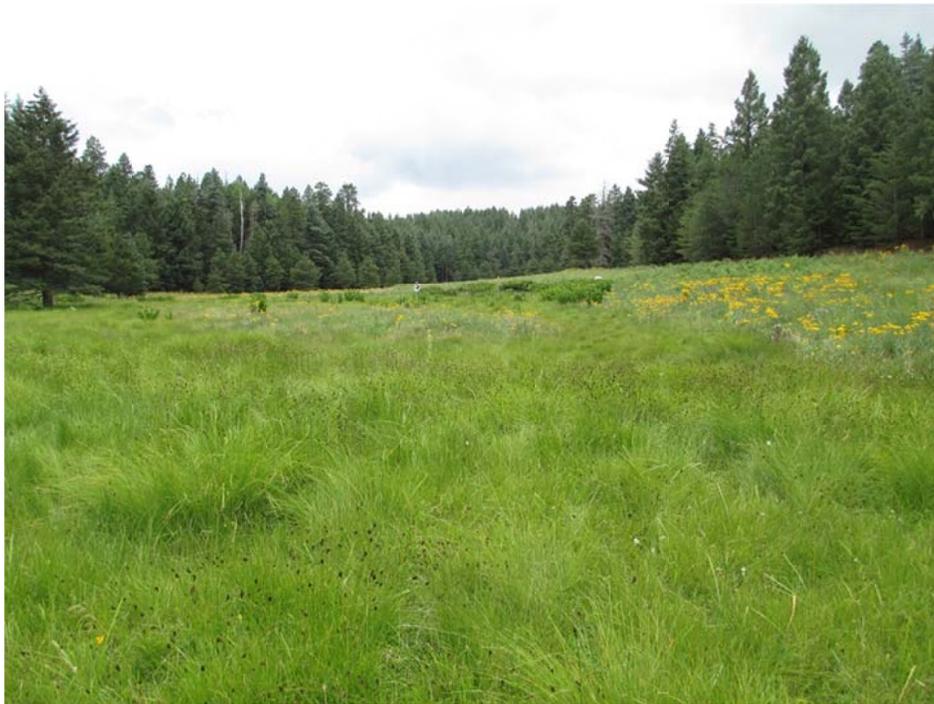
Fig 1 Western Hospital Flat Unnamed: middle section of meadow, from upper

Physical Description: Western Hospital Flat Unnamed is a helocrene spring. It is a large high elevation wet meadow with braided channels. The site has 3 microhabitats, including A -- a 160 sqm channel, B -- a 0 sqm low gradient cienega.

Management Recommendations: There is a campground just downhill and a road nearby (including one that crosses the meadow above the spring). There is an erosion ditch forming from the road. There is road sand and gravel build-up on the upper terrace.

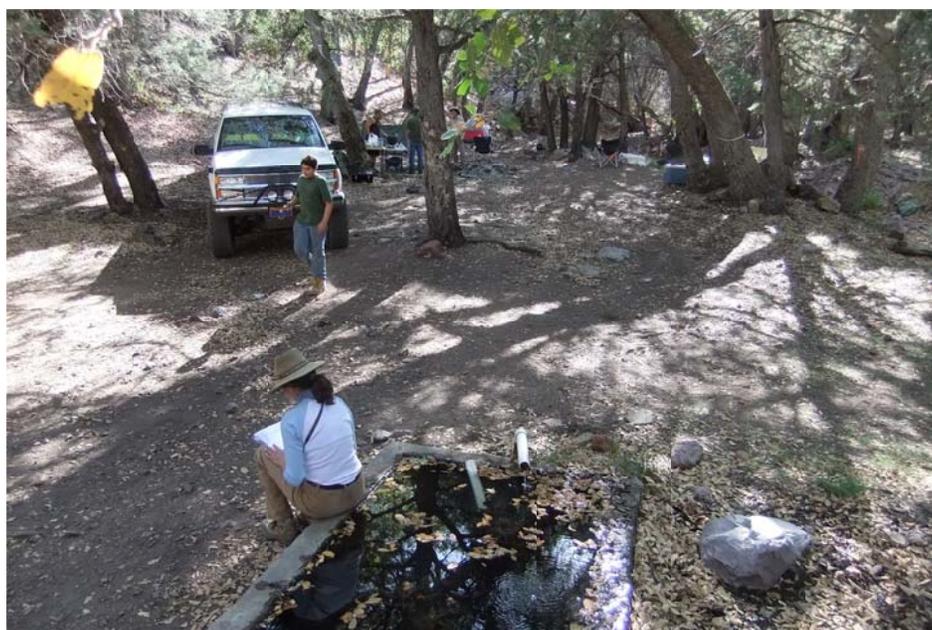
Fig 1.1 Aliso Spring.

Physical Description: Aliso Spring is a rheocrene spring. It is a partially boxed spring that is located at a well-used campsite. The geomorphic diversity is 0.00, based on the Shannon-Weiner diversity index.

Survey Notes: The surrounding campsite is heavily used and denuded and campers were present. Water is located in the a concrete tank with moist soil around it.

Assessment: Assessment scores were compiled in 5 categories and 32 subcategories, with 10 null condition scores, and 10 null risk scores. Aquifer functionality and water quality are moderate with some restoration potential and there is moderate risk. Geomorphology condition is very poor with very limited restoration potential and there is very high risk. Habitat condition is very poor with very limited restoration potential and there is very high risk. Biotic integrity is poor with limited restoration potential and there is extreme risk. Human influence of site is moderate with some restoration potential and there is very high risk. Administrative context status is undetermined due to null scores and there is undetermined risk due to null scores. Overall, the site condition is poor with limited restoration potential and there is very high risk.

Management Recommendations: Steam is flowing nearby, but not next to site. There are interrupted segments of flow (ephemeral reaches in between). Unable to determine origin of flow coming out of pipe as there is no evidence of pipe in the stream.

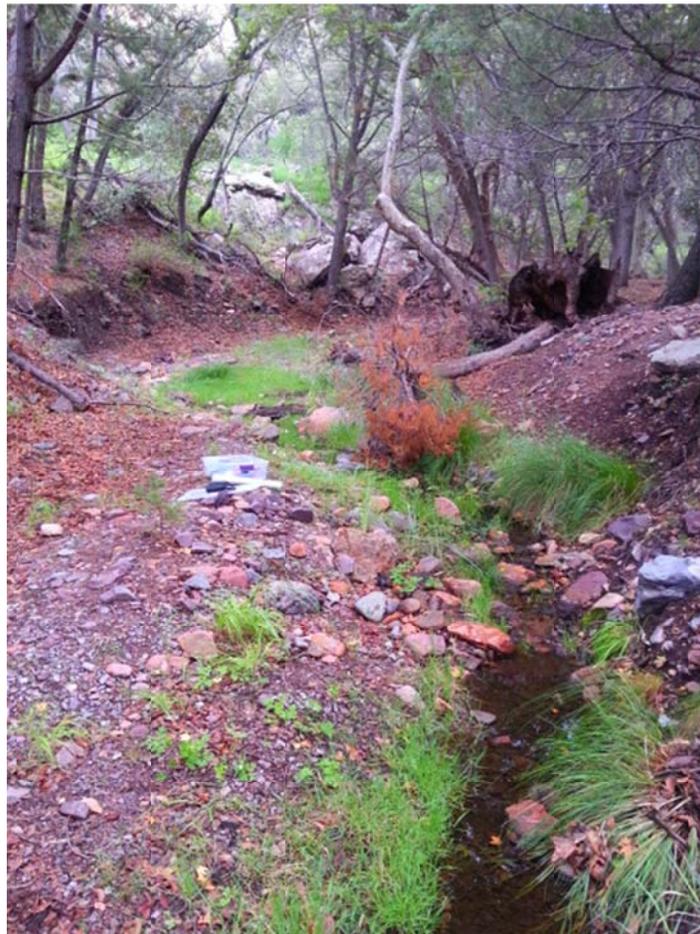
Fig 1 Aliso Spring

Physical Description: Aliso Spring is a rheocrene spring. It is a partially boxed spring that is located at a well-used campsite. The site has 1 microhabitat, A -- a 39 sqm channel. The geomorphic diversity is 0.00, based on the Shannon-Weiner diversity index.

turkeys walked to within 10 meters of the surveyors during the visit on separate occasions. Damage from recreational shooting was evident on metal signage and on over 40 trees.

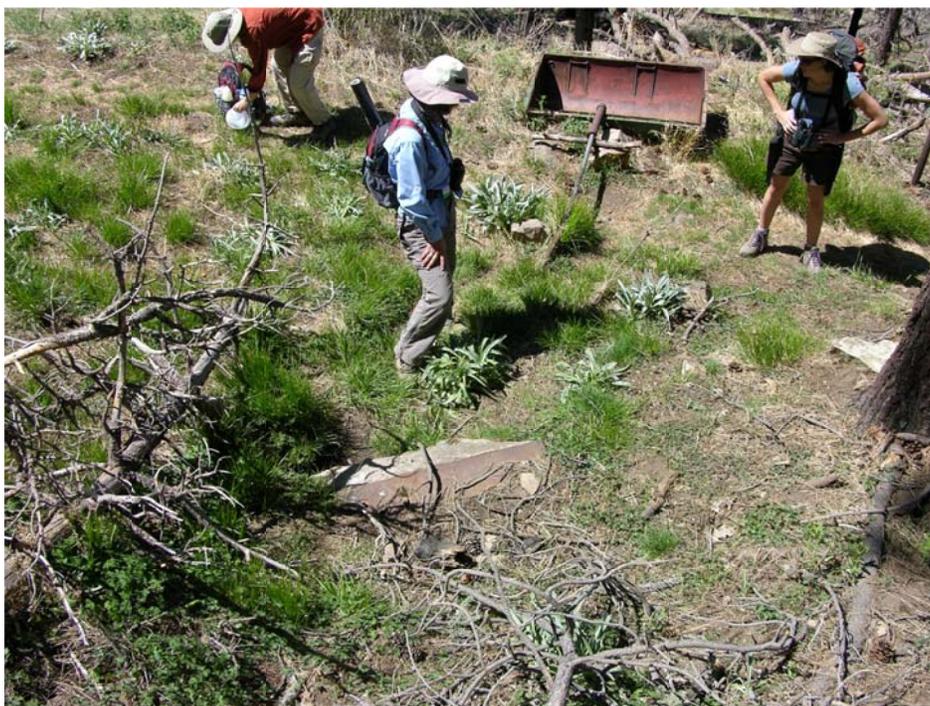
Fig 1 Baldy Spring.

Physical Description: Baldy Spring is a helocrene spring. This spring is on a relatively steep north/northeast facing slope in close proximity to a mountain pass above the origin of Gardner Canyon drainage. The spring emergence is located under within what appears to be a spring box with concrete over it in designated Wilderness. The microhabitat associated with the spring covers 35 sqm. The geomorphic diversity is 0.00, based on the Shannon-Weiner diversity index.

Survey Notes: This is a helocrene spring located in an area that was severely burned. There is a well-used hiking trail within 2 m of the spring site and the spring emergence is a small pool of water located under a concrete spring box structure. There is old piping infrastructure

going from the spring to a rusted out tank just across the hiking trail. The main microhabitat at this site is a small, very shallow pool of water located directly under the concrete.

Assessment: Assessment scores were compiled in 5 categories and 33 subcategories, with 9 null condition scores, and 9 null risk scores. Aquifer functionality and water quality are moderate with some restoration potential and there is low risk. Geomorphology condition is poor with limited restoration potential and there is moderate risk. Habitat condition is moderate with some restoration potential and there is low risk. Biotic integrity is moderate

Management Recommendations: Check for historic flow data to understand the effect the fire has had on the spring. The spring was signed by the FS so it was probably more productive at one time. This spring is of high value for recreation purposes - hikers in the Wilderness- so it would might be beneficial to look at the impact the trail and existing spring box structure is having on spring functionality. Perhaps it would benefit from cleaning the spring box. Due to the fire, the spring is very exposed and may benefit from native plant restoration to provid more shade and microhabitat shelter.
