Appendix C: Spring Inventory and Assessment Reports for Springs Surveyed for Fire Effects

Springs outside of the Upper Santa Cruz River Basin used in Fire Effects and Fuels Analysis

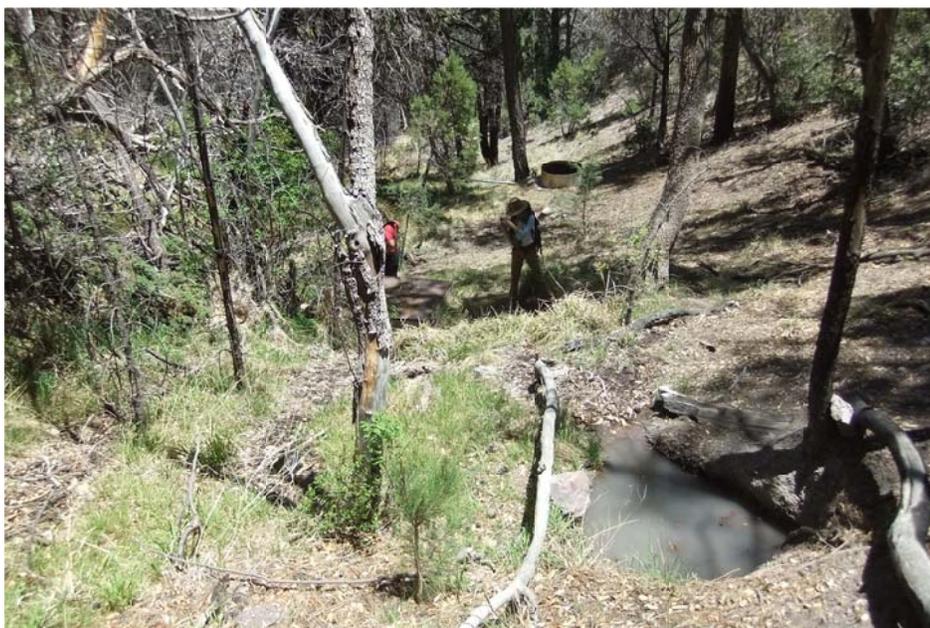
Fig 1 Sawmill Spring.

Physical Description: Sawmill Spring is a hillslope spring. The microhabitat associated with the spring covers 336 sqm. The geomorphic diversity is 0.00, based on the Shannon-Weiner diversity index.

Assessment: Assessment scores were compiled in 5 categories and 31 subcategories, with 11 null condition scores, and 12 null risk scores. Aquifer functionality and water quality are good with significant restoration potential and there is low risk. Geomorphology condition is moderate with some restoration potential and there is low risk. Habitat condition is good with significant restoration potential and there is negligible risk. Biotic integrity is good with significant restoration potential and there is low risk. Human influence of site is good with significant restoration potential and there is low risk. Administrative context status is undetermined due to null scores and there is undetermined risk due to null scores. Overall, the site condition is good with significant restoration potential and there is low risk.

Management Recommendations: The spring is next to Sawmill Canyon trail and is at risk of trampling by people. The development at the spring may need maintenance to maintain flow. Fire in the area has reduced the canopy cover but that may allow other species to thrive. Monitor for health and continue to protect from grazing.
