Appendix B: Spring Inventory and Assessment Reports for Springs Surveyed in the Upper Santa Cruz Basin Study Area

Springs surveyed in the Upper Santa Cruz River Basin

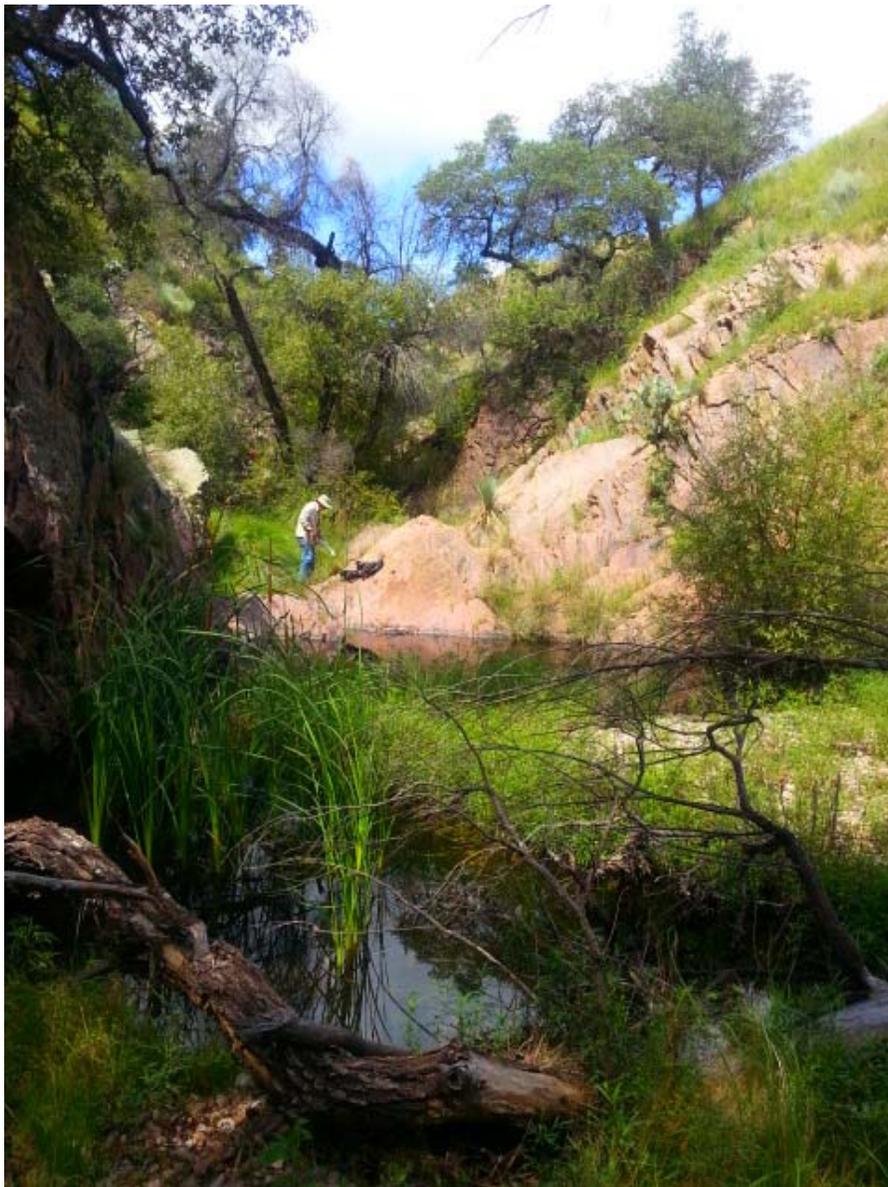
Fig 1 Alamo Spring: Upper pool.

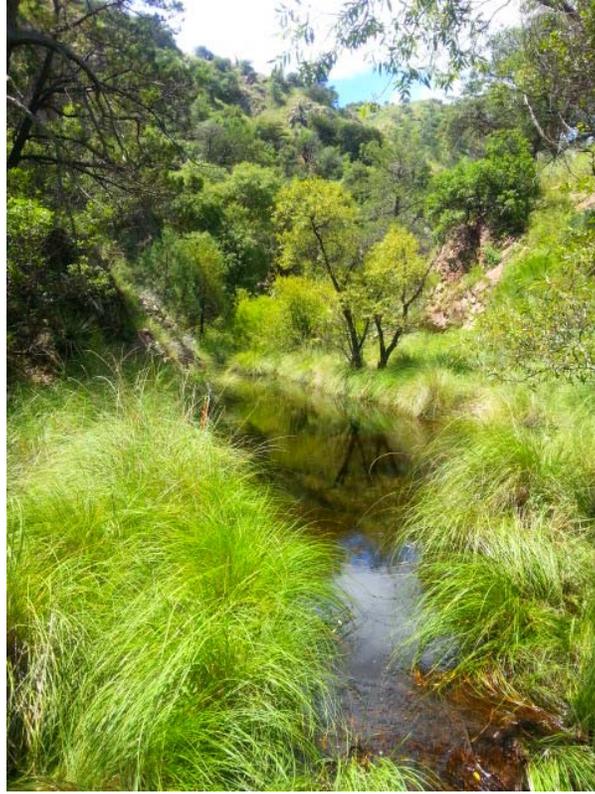
Fig 2 Alamo Spring: Middle pool.

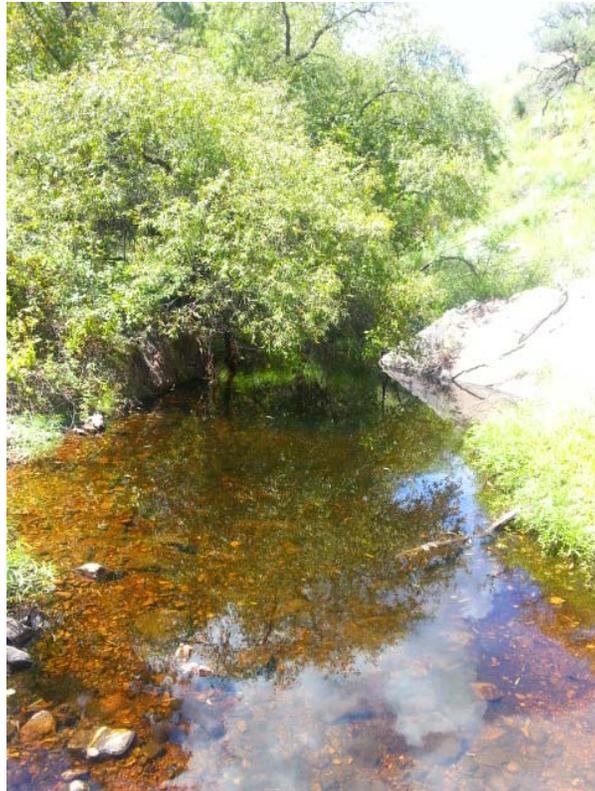
Fig 3 Alamo Spring: Lower pool.

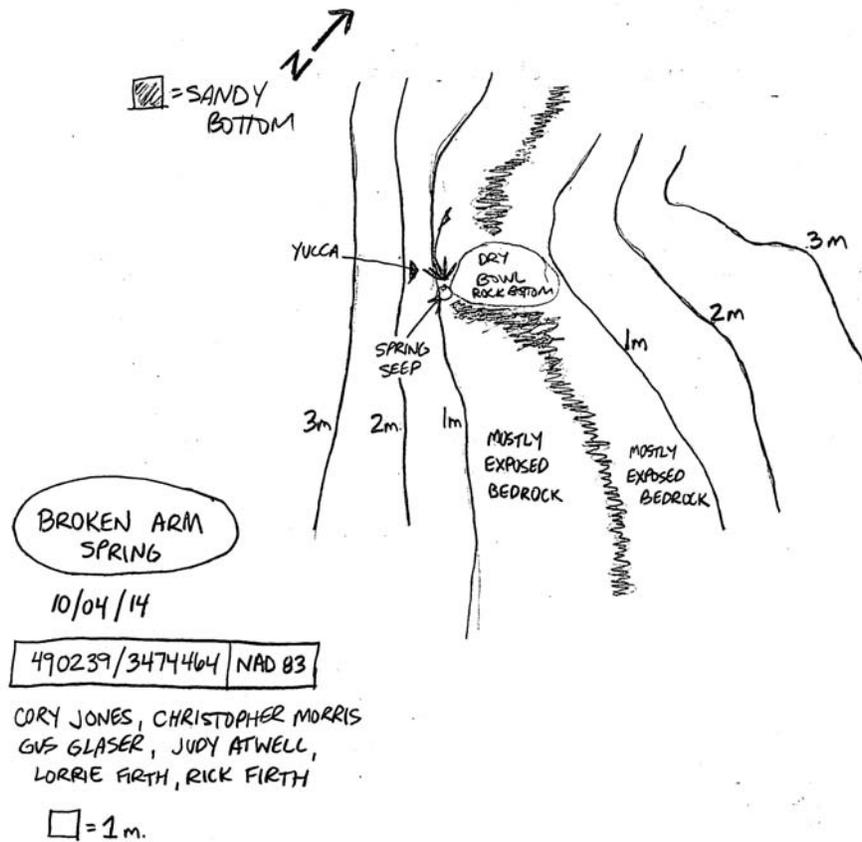
Fig 2 Broken Arm Spring Sketchmap: Sketch map.

Physical Description: Broken Arm Spring is a rheocrene spring. This spring is a wet seep emanating from the bank of a drainage channel bottomed with a combination of bedrock and sandy soils. The site has 1 microhabitat, X -- a 1 sqm backwall.

Assessment: Assessment scores were compiled in 5 categories and 28 subcategories, with 14 null condition scores, and 14 null risk scores. Aquifer functionality and water quality are poor with limited restoration potential and there is negligible risk. Geomorphology condition is moderate with some restoration potential and there is low risk. Habitat condition is moderate with some restoration potential and there is negligible risk. Biotic integrity is good with significant restoration potential and there is negligible risk. Human influence of site is very good with excellent restoration potential and there is low risk. Administrative context status is undetermined due to null scores and there is undetermined risk due to null scores. Overall, the site condition is good with significant restoration potential and there is negligible risk.

Management Recommendations: The site could be fenced off from cattle and be anchored with rocks to restart the accumulation of soils.

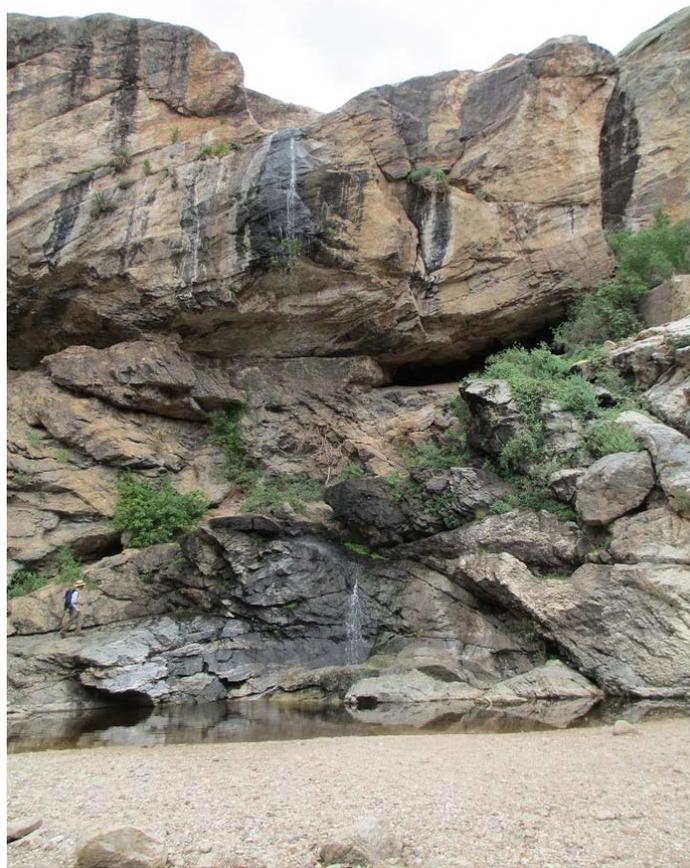
Fig 1 Chiva Falls.

Survey Notes: In good condition, though there is quite a lot of trash scattered around. There is evidence of recent flooding events and significant flow in Tanque Verde Creek above and below the spring. The pool below the spring has been silted in due to fire erosion effects - it is still functioning, but is much smaller than it used to be. There is a badly eroded, illegally constructed, road coming almost all the way to the spring.

Management Recommendations: Close the illegally constructed road that comes almost all the way to the spring.

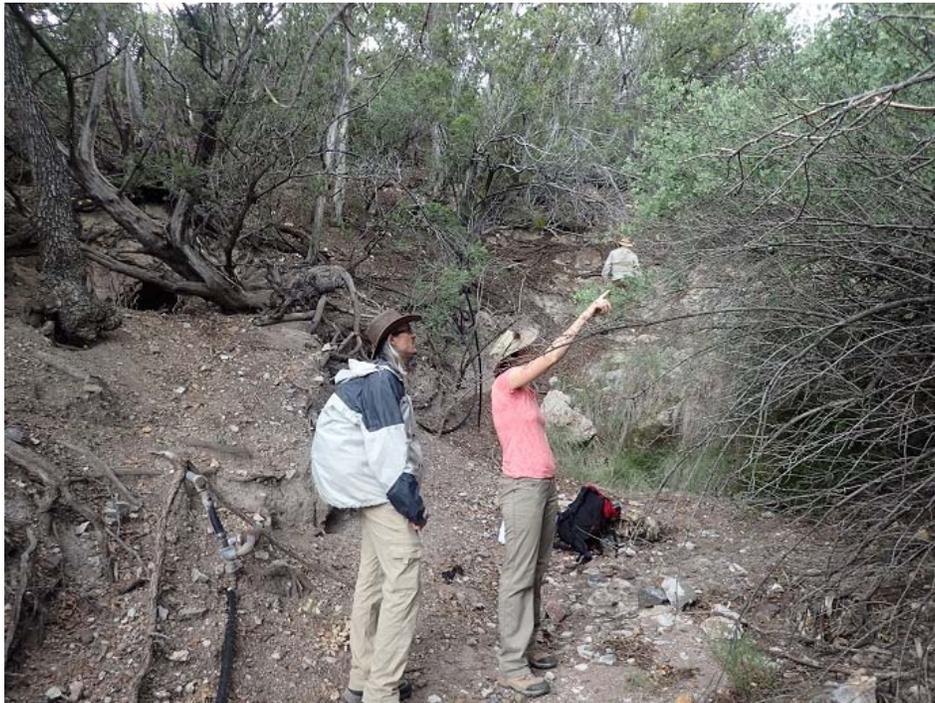
Fig 1 Deering Spring: spring origin, adit to left

Physical Description: Deering Spring is a rheocene/anthropogenic spring now emerging from a mine adit with extensive travertine deposits in the adjacent drainage. The water is piped to stock tanks. The first stock tank is at 31.808722, -110.759976. The site has 4 microhabitats, including A -- a 0 sqm pool, B -- a 0 sqm pool, C -- a 0 sqm wet hillslope, D -- a 0 sqm other.

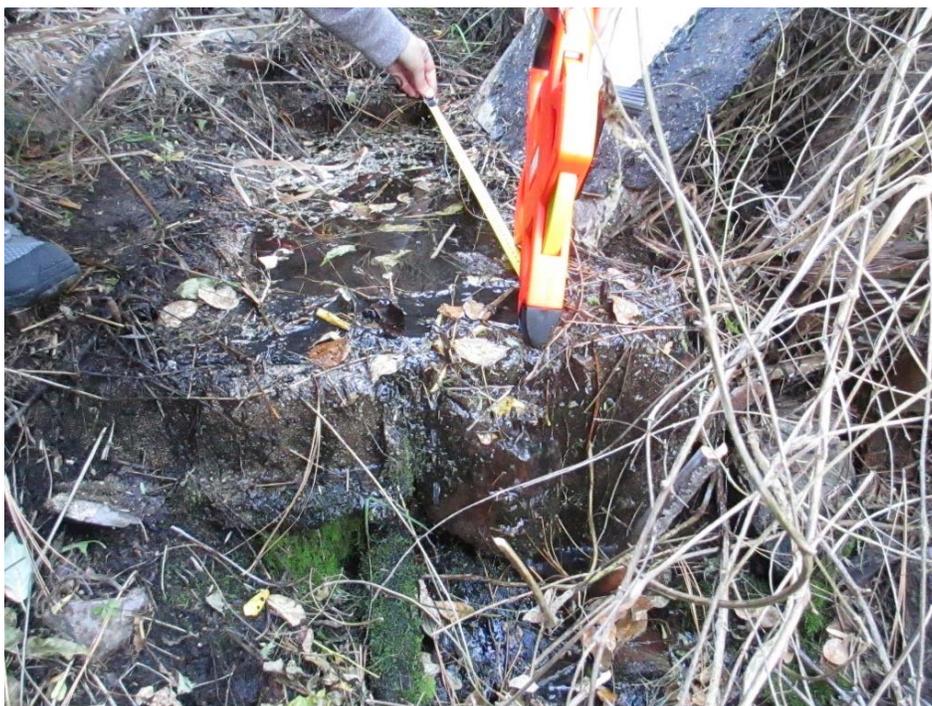
Fig 1 Florida Spring.

Physical Description: Florida Spring is a rheocrene spring. Florida Spring is a wet pocket captured by a spring box and piped all the way down the canyon. On its shaded northern aspect, the morning sun does not hit it at all in the dead of winter. The site has 1 microhabitat, A -- a 23 sqm channel.

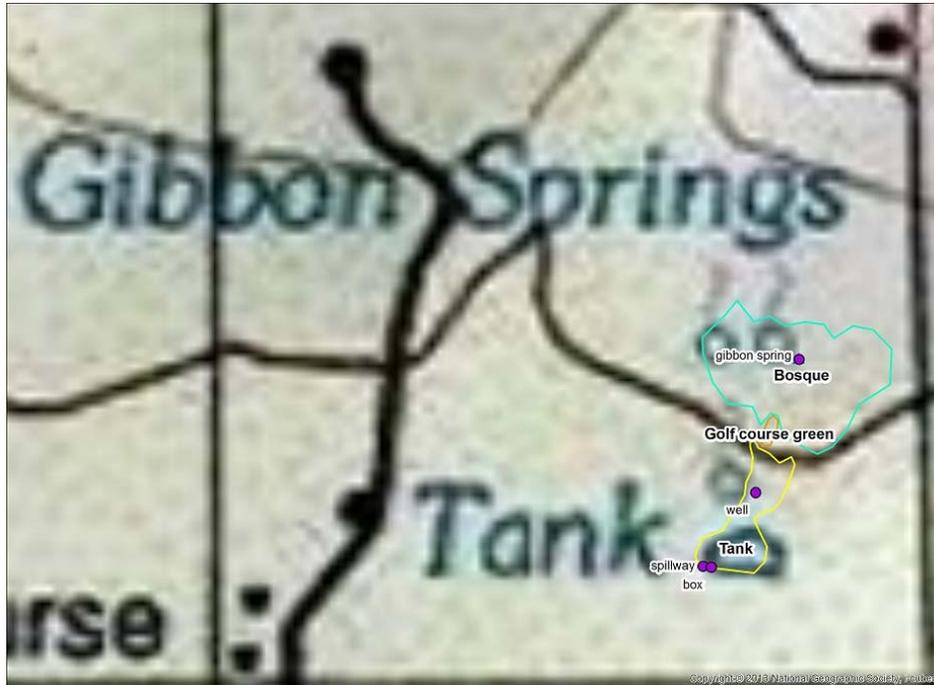
Management Recommendations: The human influence scores really depend on whether the residential development and the golf course caused the spring to dry up, or if it was due to climate alterations and natural processes in the detachment fault that the spring emerges from. These scores assume it had more to do with the human causes.

Fig 1 Gibbon Springs Sketchmap: The topo map shows other springs in the immediate vicinity which we didn't check for.

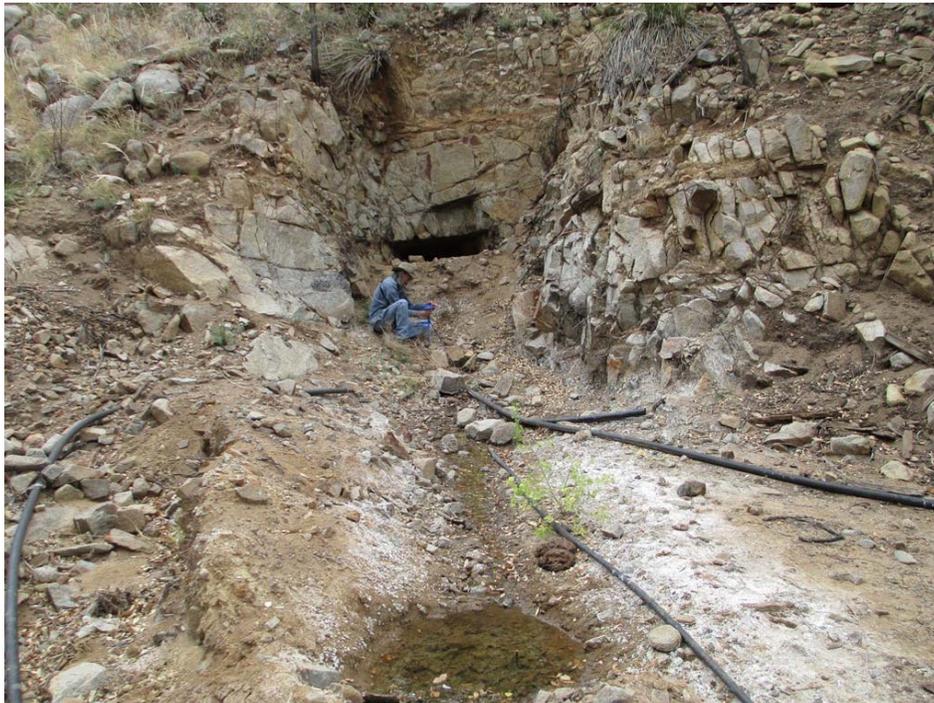
Fig 1 Jackalo Mine Spring.

Physical Description: Jackalo Mine Spring is an anthropogenic spring. There is an old mine shaft site that now has a constant water flow in a very steep rocky canyon that shows no signs of natural water presence. The mine shaft is dammed by dirt and rock with two pipes leading out of it. The microhabitats associated with the spring cover 185 sqm. The site has 4 microhabitats, including A -- a 3 sqm pool, B -- a 82 sqm other, C -- a 80 sqm adjacent uplands, D -- a 20 sqm channel. The geomorphic diversity is 0.45, based on the Shannon-Weiner diversity index.

Management Recommendations: Confirm water rights and enforce them. We believe it is currently being used for watering cattle but has also been used for supplying water to exploratory mining.

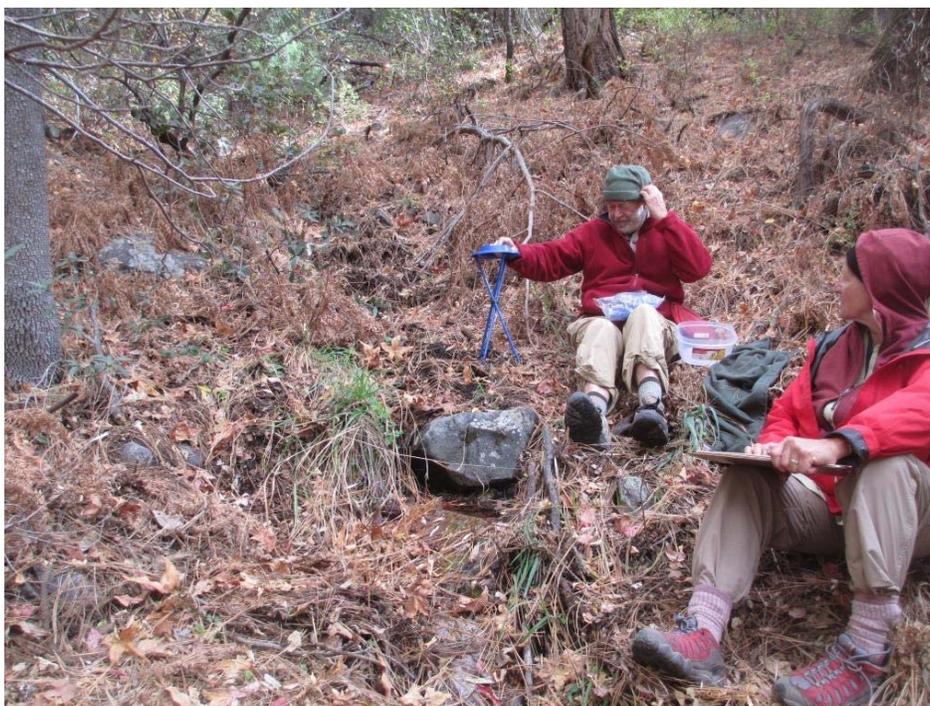
Fig 1 Kent Spring.

Physical Description: Kent Spring is a hillslope spring. Kent Spring is to the southeast of Bog Springs and is also on the eastern slope of Madera Canyon. It is a hillslope spring emerging to the side of a main channel.

Management Recommendations: This is a small spring in good condition on a steep slope in a narrow channel. It looks like it may have been developed/piped at some point in time but was free flowing at this visit due to an old tank below. It is located close to a popular hiking trail but does not appear to get much use from hikers. Near a much large channel that has been severely eroded by post-fire flooding.

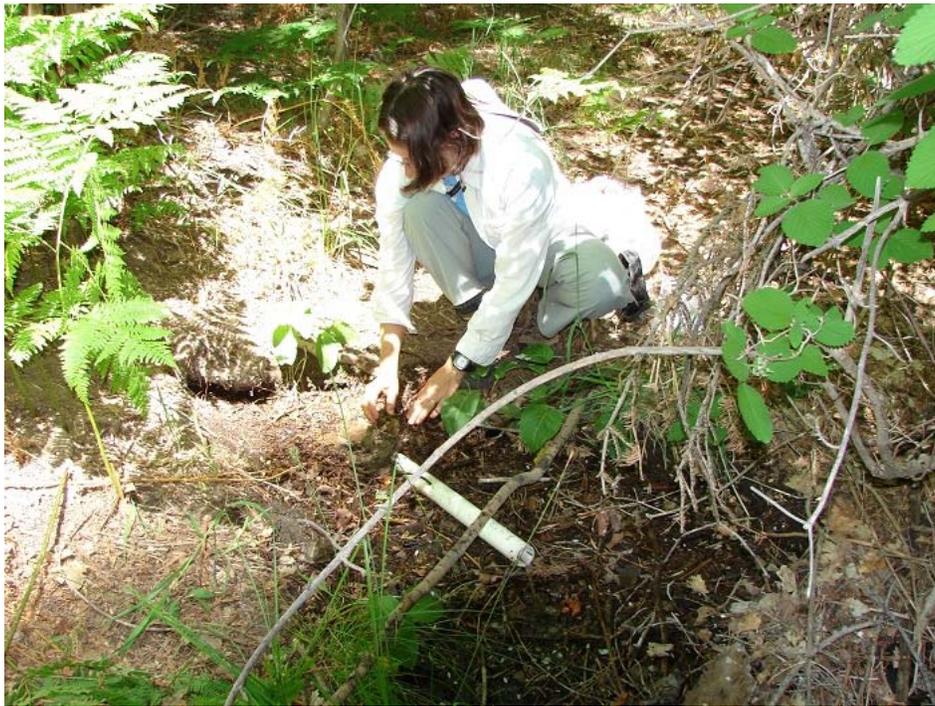
Fig 1 Kinglet Spring.

Survey Notes: The site is in very good condition - it supports a sedge and fern-lined run. There was some human trash (plastic, paper). The solar pathfinder was left behind at the vehicle, but the spring is at the NE side of the root ball of a Douglas fir, so it only receives limited sunlight in the afternoon. Also, in the morning, the sunlight is blocked by tall conifers.

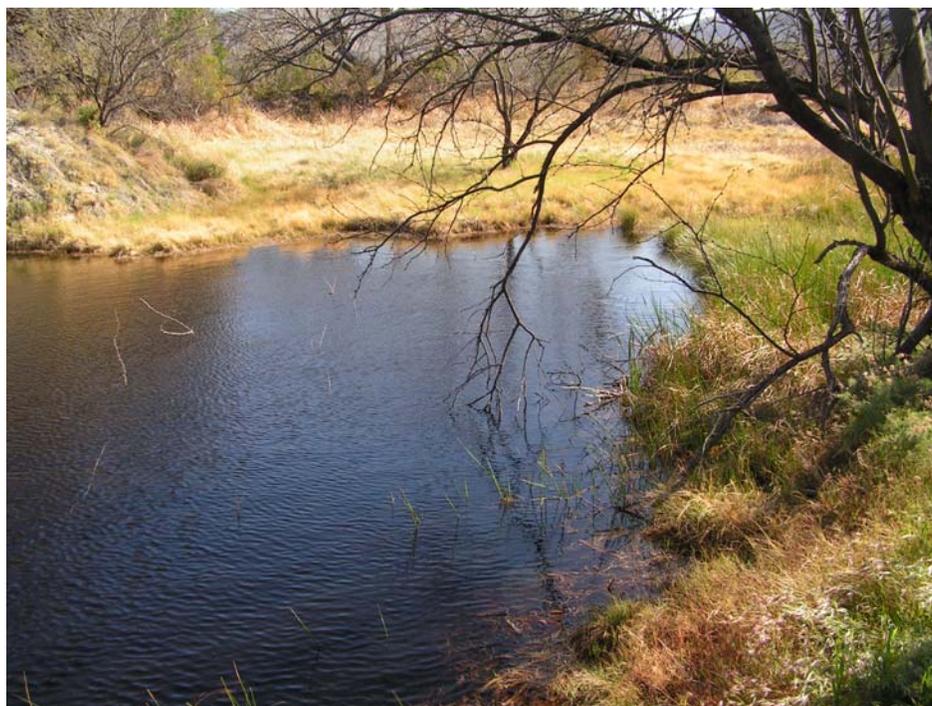
Fig 1 La Cebadilla Cienega.

Physical Description: La Cebadilla Cienega is a helocrene spring. It is a large (several hectare) cienega that is surrounded by private homes and is well-protected by the home owner's association. Discharge from the cienega is piped to a one-acre pond at which Rich Bailowitz has detected 44 dragonfly species, the highest point diversity of Odonata in Arizona. The microhabitats associated with the spring cover 43695 sqm. The site has 2 microhabitats, including A -- a 10671 sqm pool, B -- a 33024 sqm low gradient cienega. The geomorphic diversity is 0.24, based on the Shannon-Weiner diversity index.

Encroachment of phreatophytic native arborescent shrubs indicates potential risk to open wet meadow habitat. Control of shrub invasion can be accomplished with controlled burns or mechanical removal. Cienega water table is high but is diverted to support large, dragonfly rich pond. Maintaining both the cienega and the pond may require trade-offs during dry years as regional groundwater levels decline. There is evidence of historic terracing that may influence plant community structure. We recommend development of a detailed land survey, soil analysis, several monitoring wells, and more detailed inventory and vegetation mapping of this extraordinarily healthy cienega.

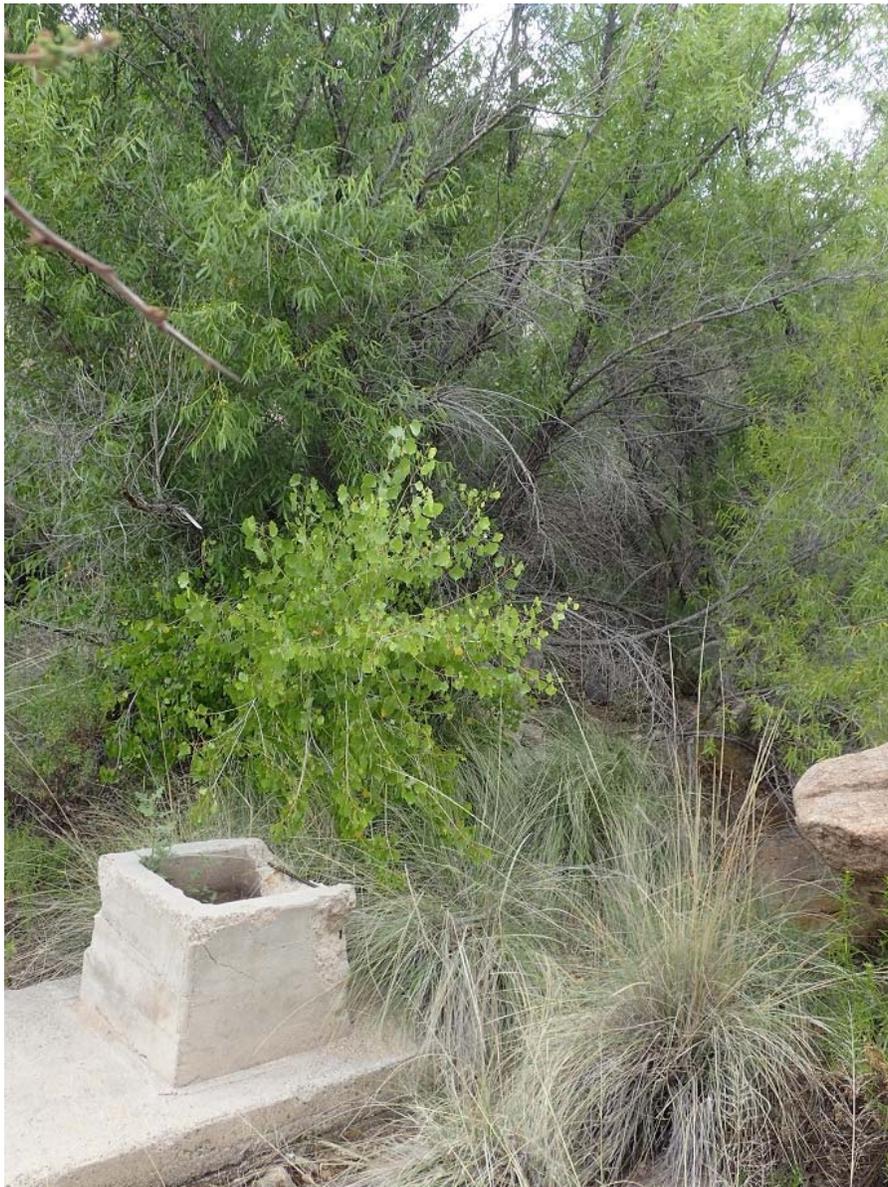
Fig 1 Mercer Spring.

Survey Notes: The site was dry, with two old concrete spring boxes. There were lots of riparian woody plants, and water stains on the rocks, suggesting the spring flows regularly, if not year-round. It would be interesting to check in spring or monsoon season.

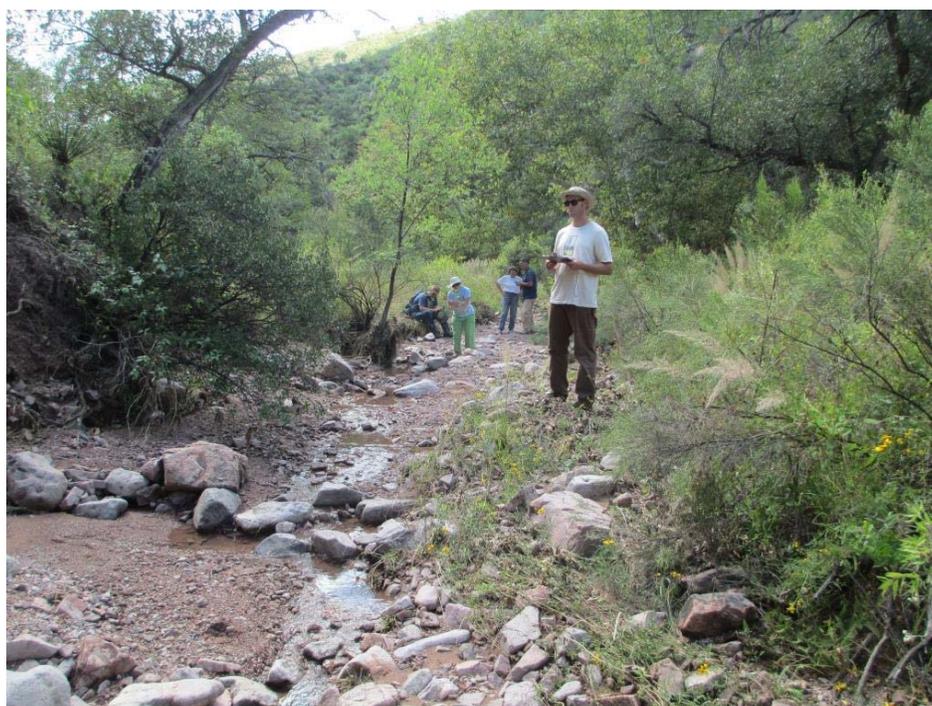
Fig 1 Mine Shaft unnamed north: Looking upstream. Source of spring is at base of ash tree on the left side of channel.

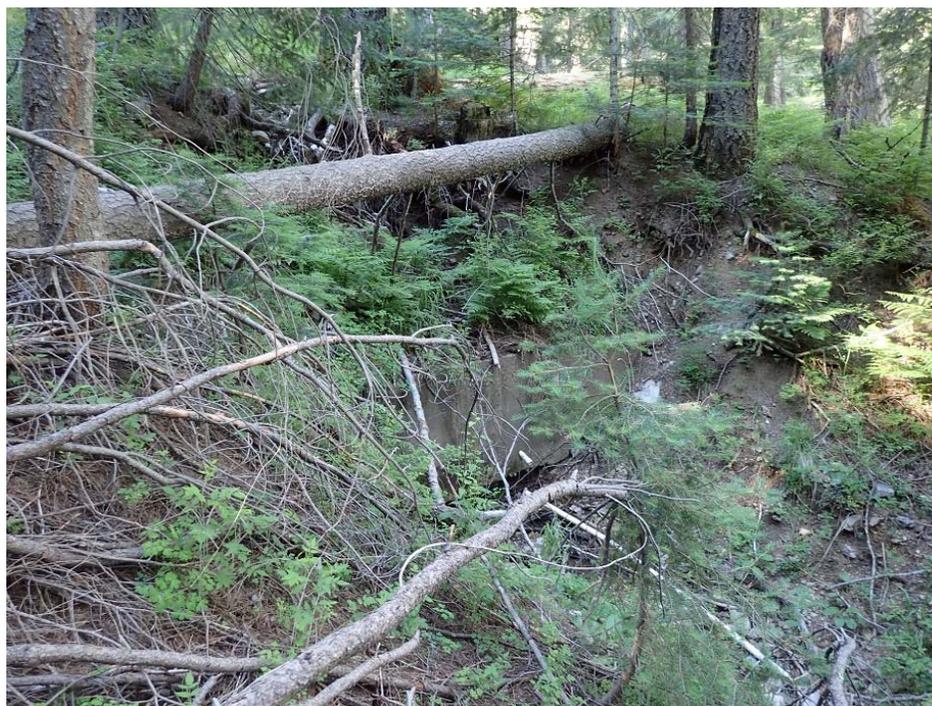
Fig 1 Observatory unnamed.

Physical Description: Observatory unnamed is a rheocrene spring. A small concrete dam in a drainage captures the flow from this spring near a road and trail. The dam is full of sediment, and water flows from a pipe in the base of the dam. The microhabitats associated with the spring cover 25 sqm. The site has 2 microhabitats, including A -- a 10 sqm channel, B -- a 15 sqm channel. The geomorphic diversity is 0.29, based on the Shannon-Weiner diversity index.

Survey Notes: The spring is in an unburned area of forest with some large trees. The pipe is broken just after it exits the dam. The dam is completely filled in with sediments, ferns, and

Management Recommendations: The road above the site may pose some risk. The dam alters the natural physical disturbance regime, obliterated the natural emergence microhabitat, is completely silted in, and is being undermined from the bottom.

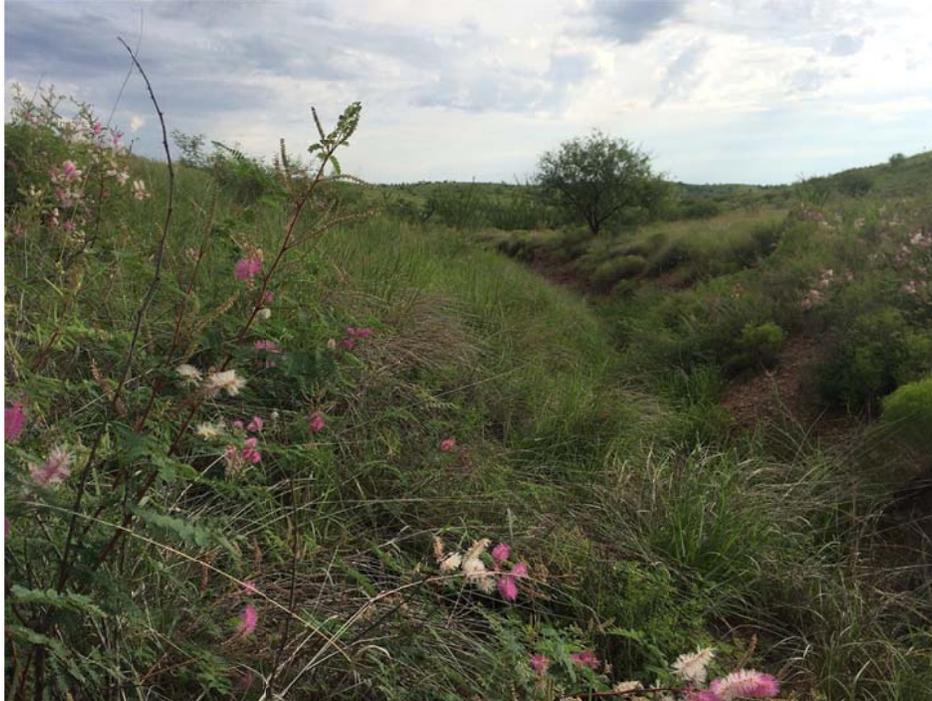
Fig 1 Ocotillo Spring: drainage near coordinates

Survey Notes: Surveyors found no developed spring, only some very moist, slightly muddy soil in a minor drainage at the coordinates, directly below an ocotillo. With recent monsoon season precipitation, the source of the water is uncertain. There was no vegetation indicative of a spring. The Pima Co GIS layer may possibly refer to one of two stock tanks, one 750m away on a bearing of 58 degrees, or one 1200m away on a bearing of 100 degrees.

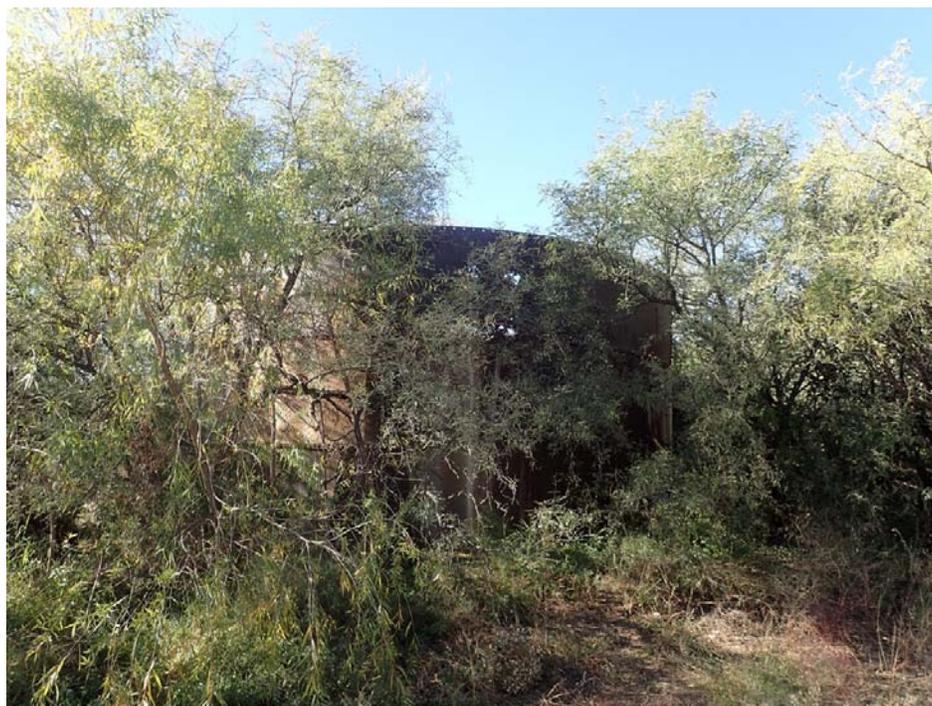
Fig 1.1 Papago Spring: the tank/cistern

Survey Notes: The tank/cistern is rusted through about halfway up, causing water to cascade out of it in several places - much of the spring habitat is probably here currently. There is a functioning float in the trough, keeping it about half full. The windmill is functioning, with

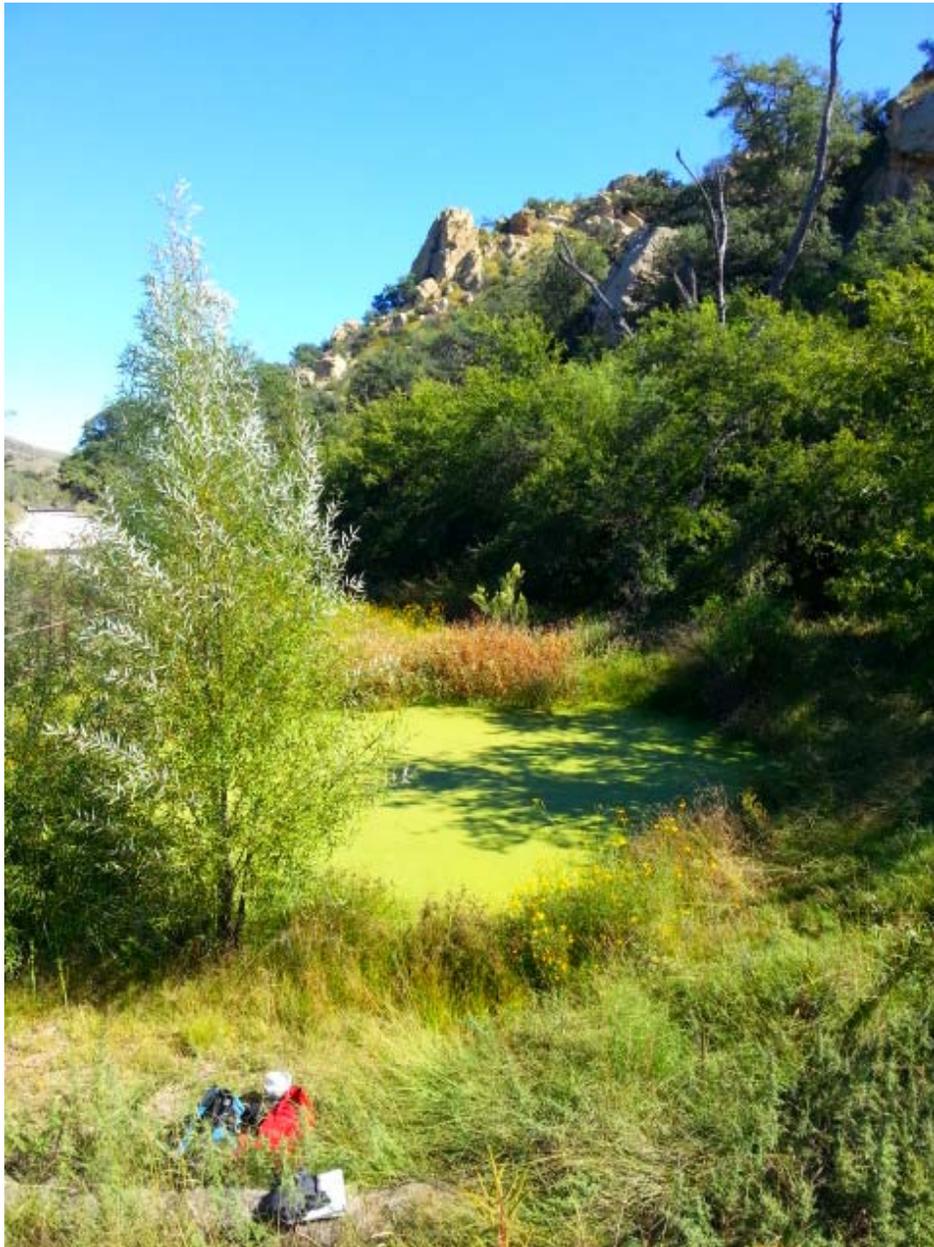
Fig 1 Pena Blanca Spring *: Pond site at Pena Blanca. Ruby Road to left. Corral right of photo.

Survey Notes: Two Chiracahua leopard frogs were present at the full water trough. Water spilling over its walls was draining towards the pond. The pond was covered in algae and over 30 CLFs were observed. A vibrant field of rushes were growing in slowly draining water from the shallow banked northern edge of the pond.

Management Recommendations: A water sample was taken and will be analyzed by the University of Arizona. This site provides great habitat for Chiricahua leopard frogs and other wildlife species with the exclusion to cattle. It is recommended to continue monitoring the site.

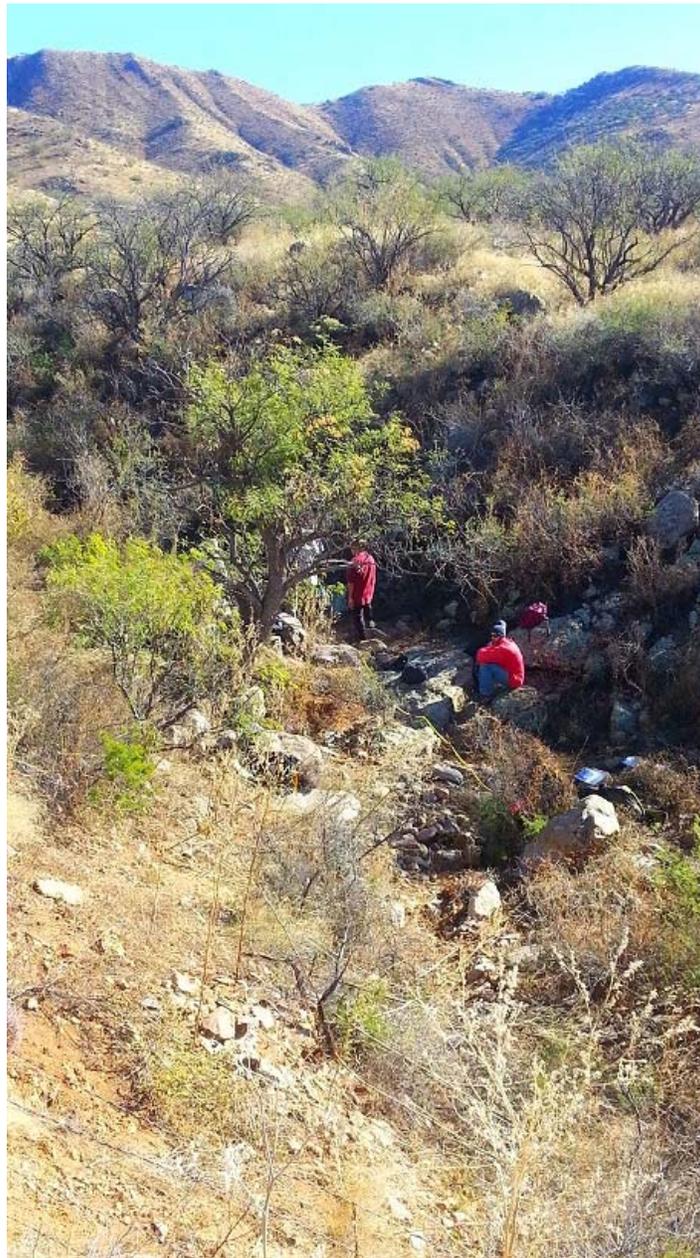
Fig 30.1 Proctor Spring.

Survey Notes: The site was dry with no noticeable aquatic vegetation in the area. This spring was not counted as being found.

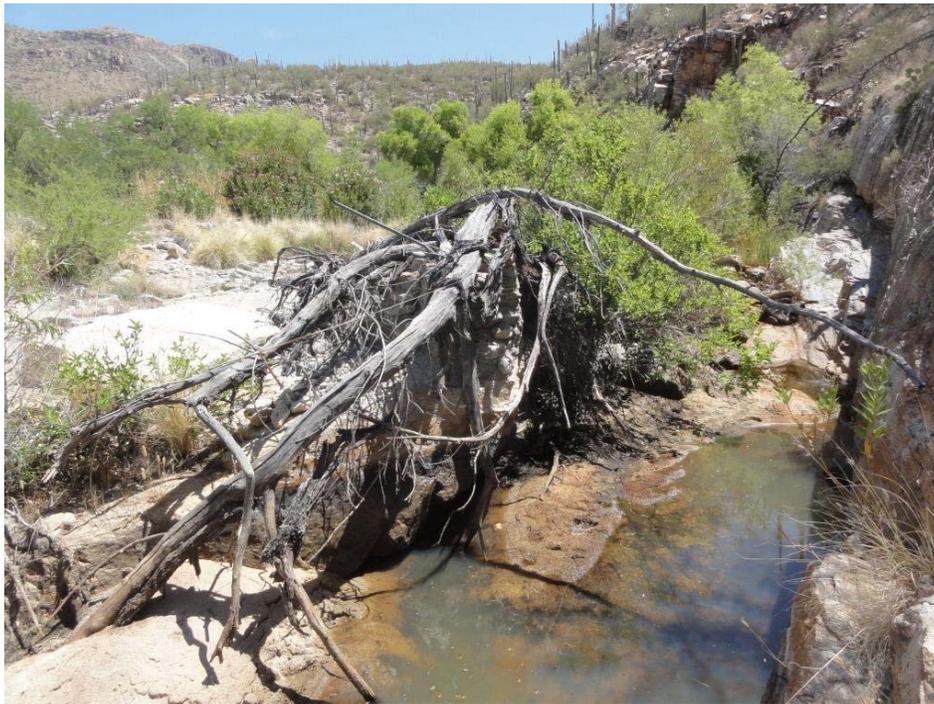
Fig 1 Rancho Fundoshi Spring: Looking up Bear Canyon at spring source.

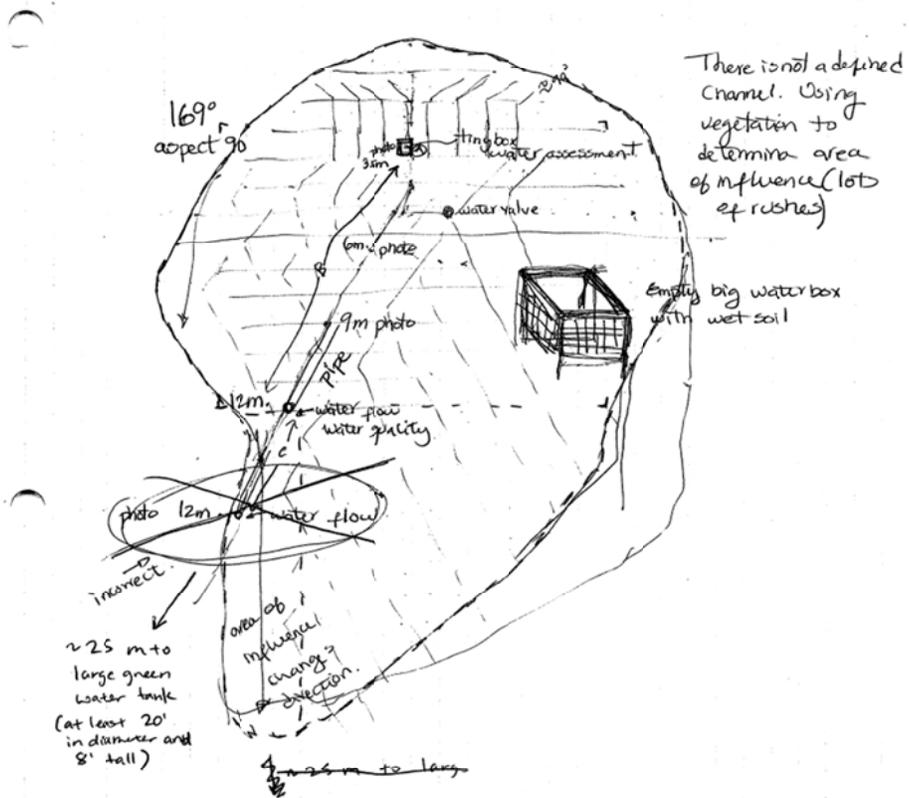
Fig 1 Ranger Station unnamed Sketchmap.

Survey Notes: The spring appears to be in good condition, but quite altered by humans. It is probably piped to the large green tank below, which may be the water source for the adjacent boy scout camp. The springbox clinging to the hillside is empty with wet soil. There are lots of alders! Most of the flow at the flow measurement point was captured, but it is possible that most of the flow is actually piped to the tank via other unseen pipes, which would indicate the reported flow rate only represents a small proportion of the spring's total output.

Management Recommendations: There is a sewage pond relatively close to the site, but it is across the drainage, so probably does not influence the spring.

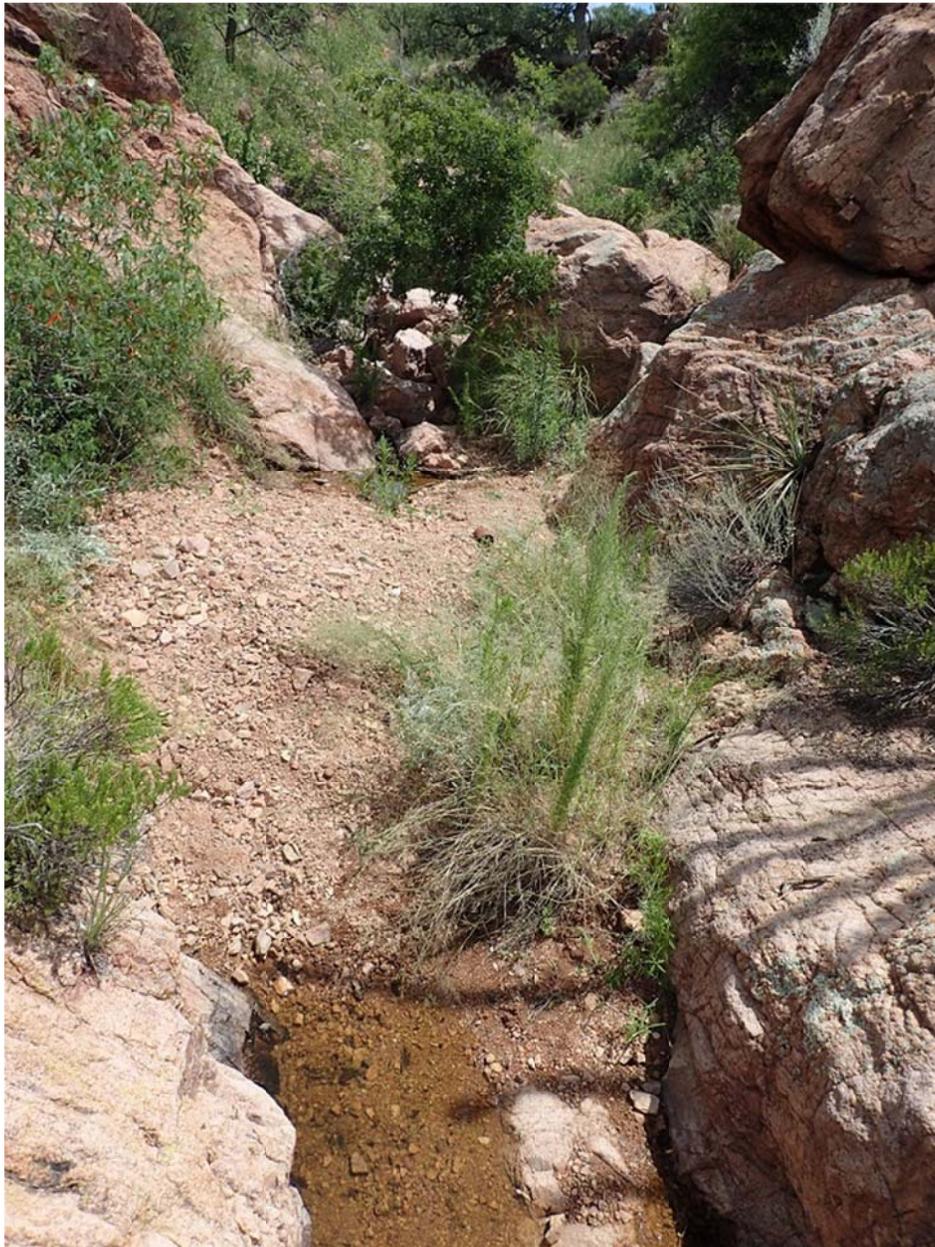
Fig 1 Red Spring.

Physical Description: Red Spring is a rheocrene spring. At this location there is a rocky stretch of wash with standing water; water marks on the rock suggest that water is persistent at the site. It is possible the water in the stream is not from a spring, but monsoon precipitation (though some plants indicate it may be spring-fed); there is an unusually dense patch of trees that is prominent on satellite imagery at the original imported coordinates between the road and the drainage. We did not find an obvious spring there, but perhaps the search was not intensive enough, or the spring is a hypocrene type (see images on 7/31/15 survey). The site has 4 microhabitats, including A -- a 8 sqm pool, B -- a 0 sqm channel, C -- a 27 sqm sloping bedrock.

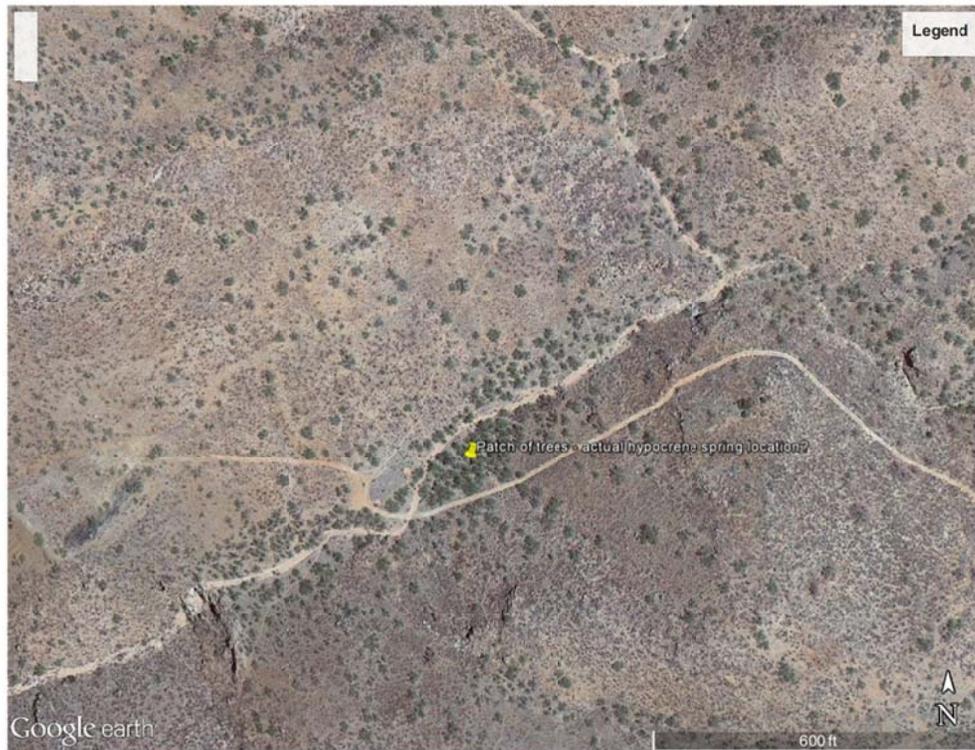
Fig 3 Red Spring: The spring may actually be at these original coordinates and hypocrene?

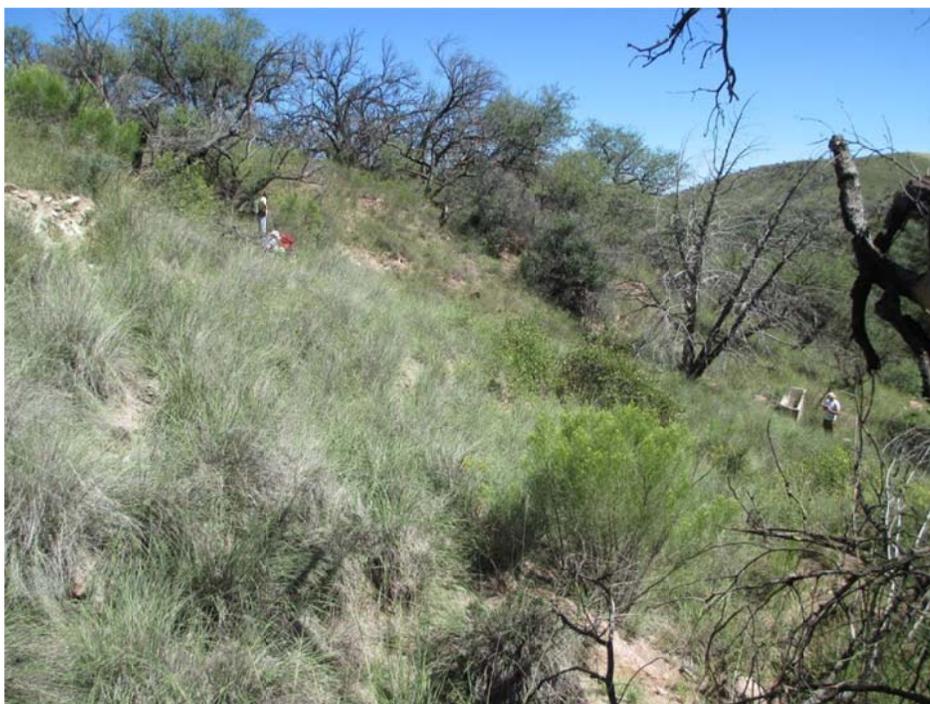
Fig 1 Rock Water Spring: Origin is where people are to the left. Piping runs to site below.

Physical Description: Rock Water Spring is a hillslope spring. The site consists of an almost dry seep within a narrow and deeply downcut channel below an access road surrounded by slopes carpeted in deergrass and mesquite. There is non-functioning cattle watering infrastructure below the seep and just above the confluence of a more prominent drainage. The site has 1 microhabitat, X -- a 782 sqm wet hillslope.

Survey Notes: The site believed to be the spring source is within an incised channel. Evidence of water at the site consists of nothing more than about one square foot of moist sand. There's an old rectangular cement trough below and broken piping running between.

Management Recommendations: The access road above the site has led to significant downcutting in the channel where the spring seep originates. Closure of the access road and erosion mitigation work would positively affect site conditions.
